CROYODN ROAD RECREATION GROUND THE McCALLUM & HOPE BANDSTAND c.1891? PROPOSED RESTORATION WORKS

FINDINGS OF INITIAL INVESTIGATION

AND PRELIMINARY BUDGET INFORMATION

NOVEMBER 2013

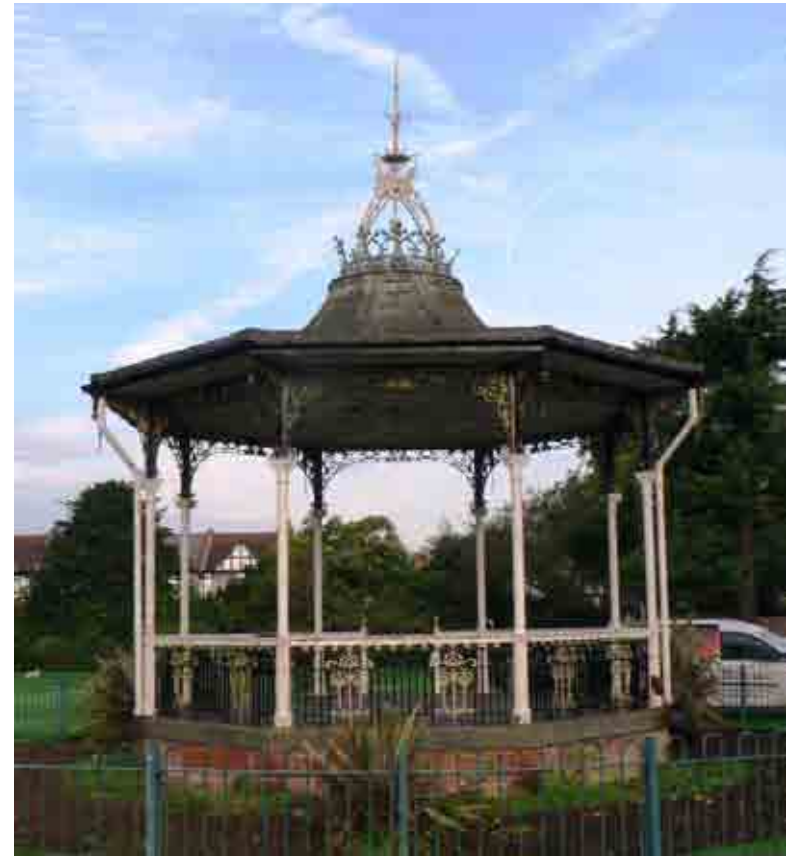
Possible 1891 – 1909 dates given. Antefix detail
in evidence in original design.

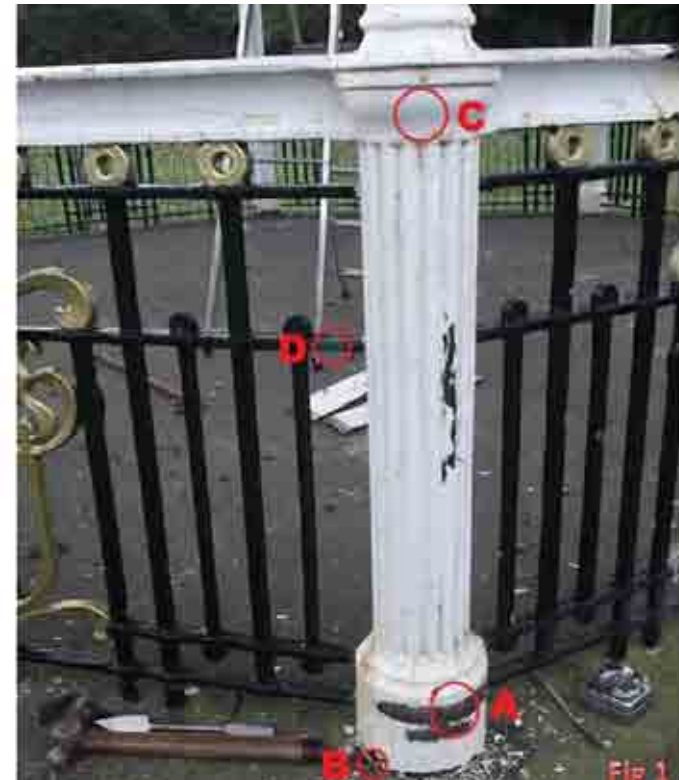
Lead present within base coats

Paint and surface was tested in three areas and tests proved positive for lead in all cases.

Lead presence will require additional risk assessment and health and safety protocols to contain, capture and dispose of harmful material on removal, at a significant cost.

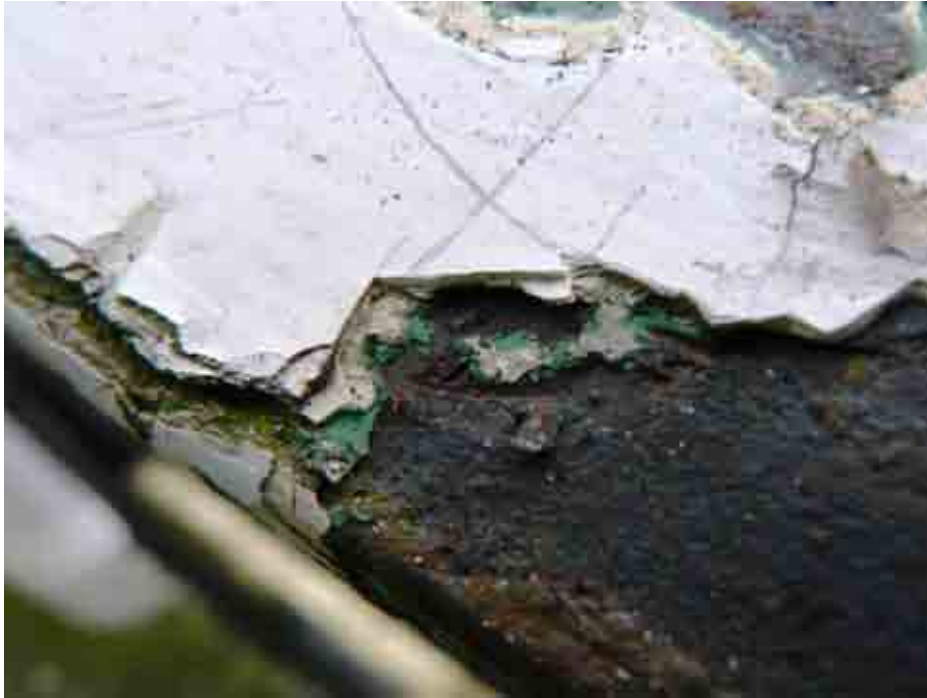
Handrail paint layers in close up. Evidence of early Green layers under cream and white coats.

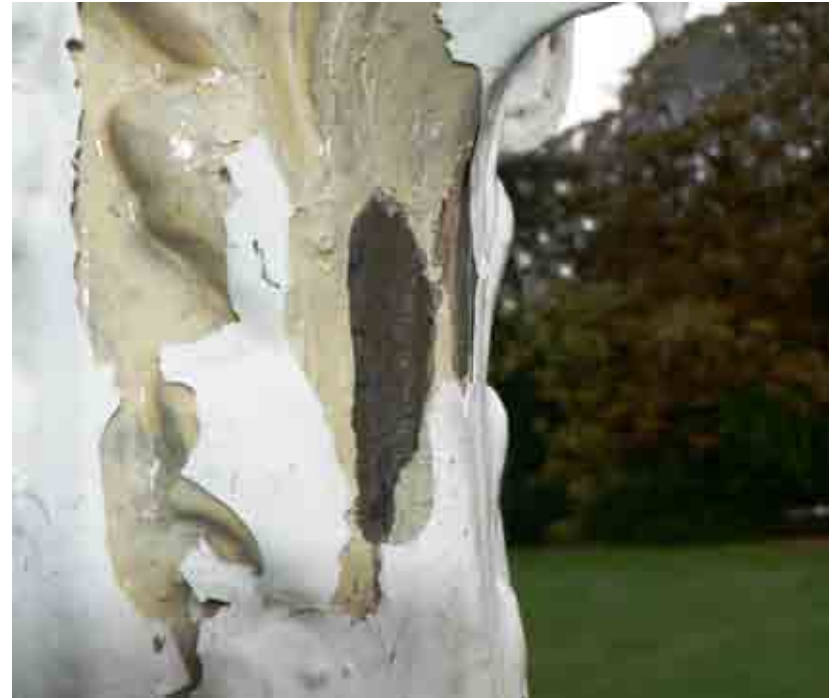
Composite capital paint layers in close up. Evidence of early dark Green layers under cream and white coats. Lead paint (Cream) below Acrylic (White)

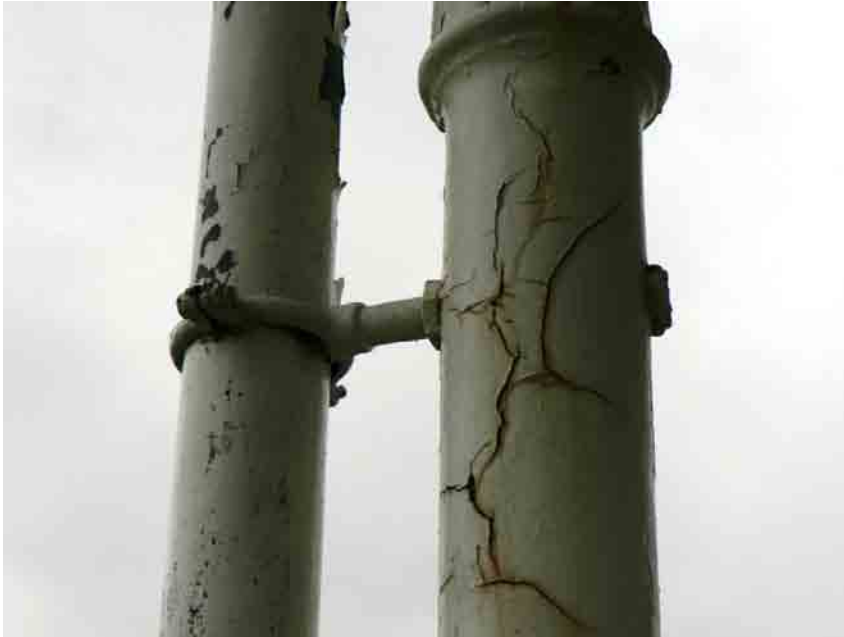
Inappropriate fixing detail through body of cast down pipe. Difficult to achieve and source of moisture ingress and potential freeze thaw action and mechanical damage to the downpipe.

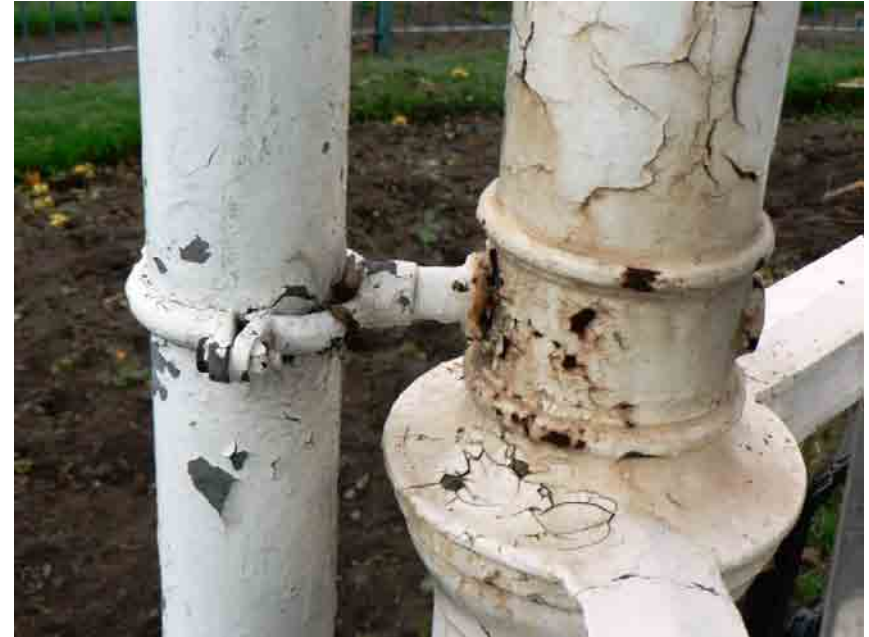
Inappropriate fixing detail through body of cast down pipe. Connection to handrail under threat. Should be removed and made good.

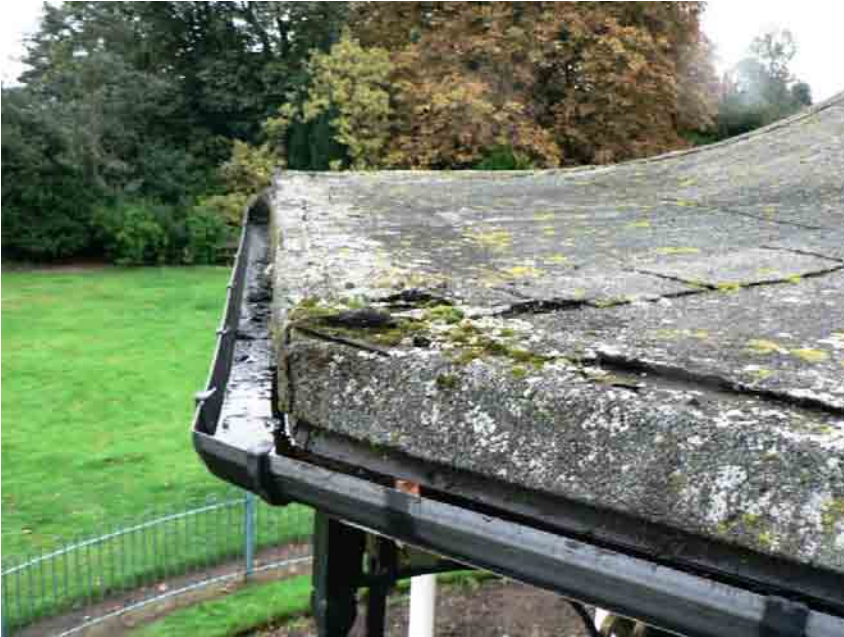
Gutter line altered in the past. Early evidence suggests ogee shaped gutter with higher sides and Antefix Palmette detail to centres. Mounting position for gutters altered, timber removed at an earlier date.

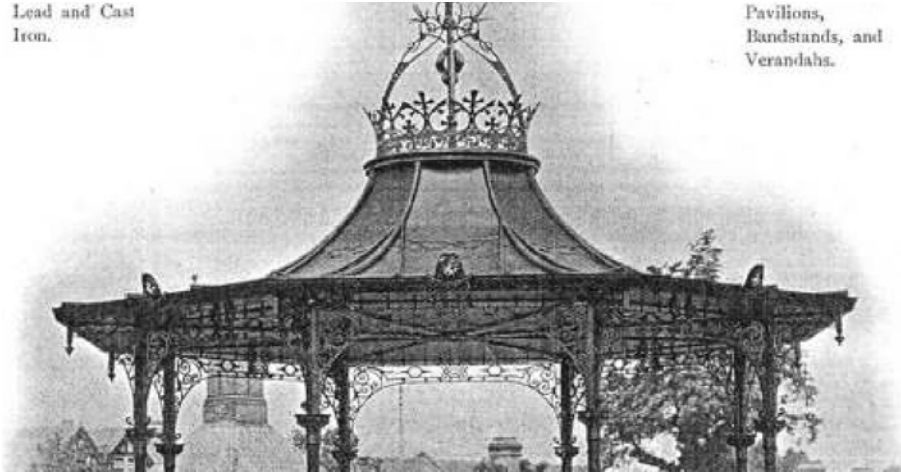
Was water thrown clear of gutter line?

Was internal downpipe employed through cast section?

Are cast sections viable to carry rainwater?

Further design needed.

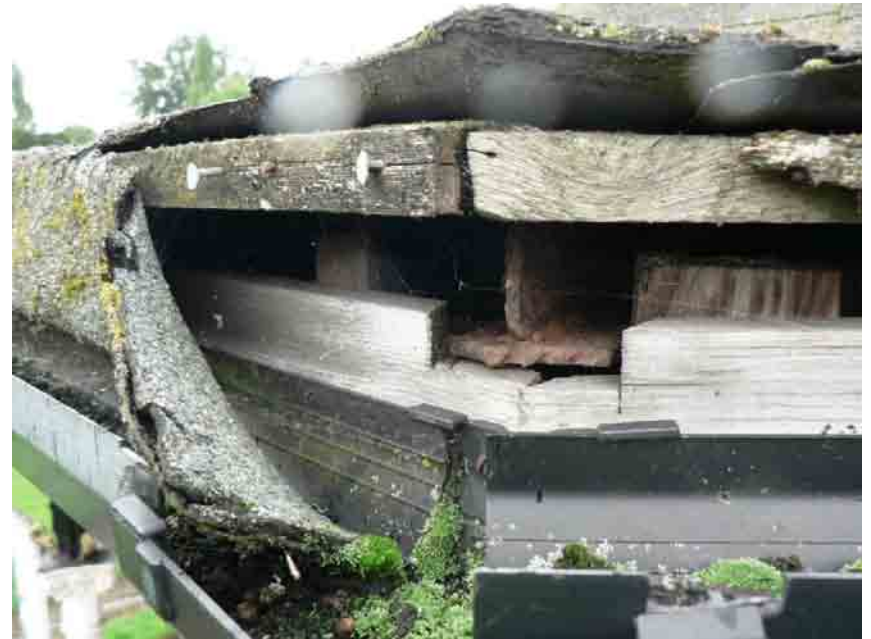
Guttering detail ultimately unknown due to lack of remaining original timber work. Roof iron frame work visible to corner section.

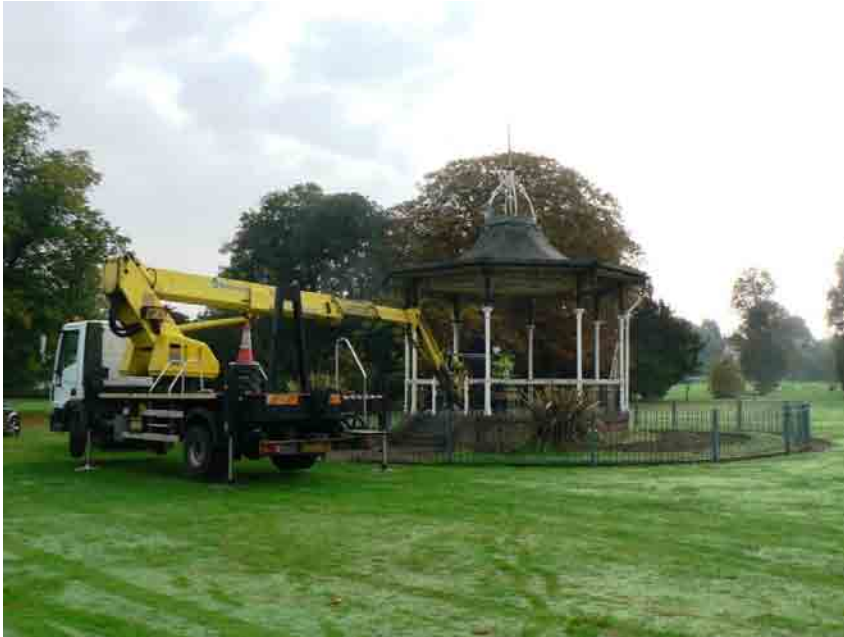
MEWP employed to reach the soffit, roof and corona for detailed inspection

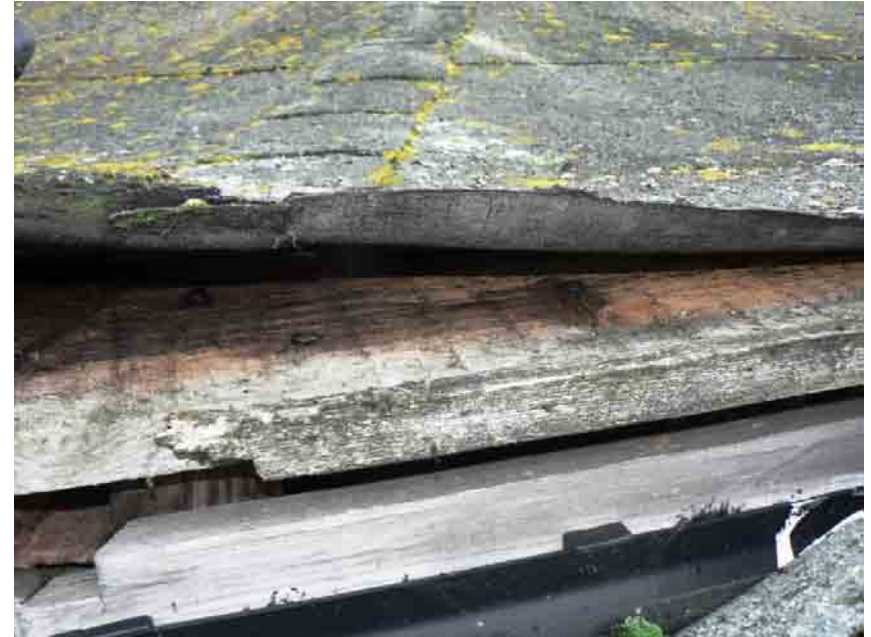
Low quality roofing felt laid directly onto timber boarding. Timber work damage not excessive where exposed.

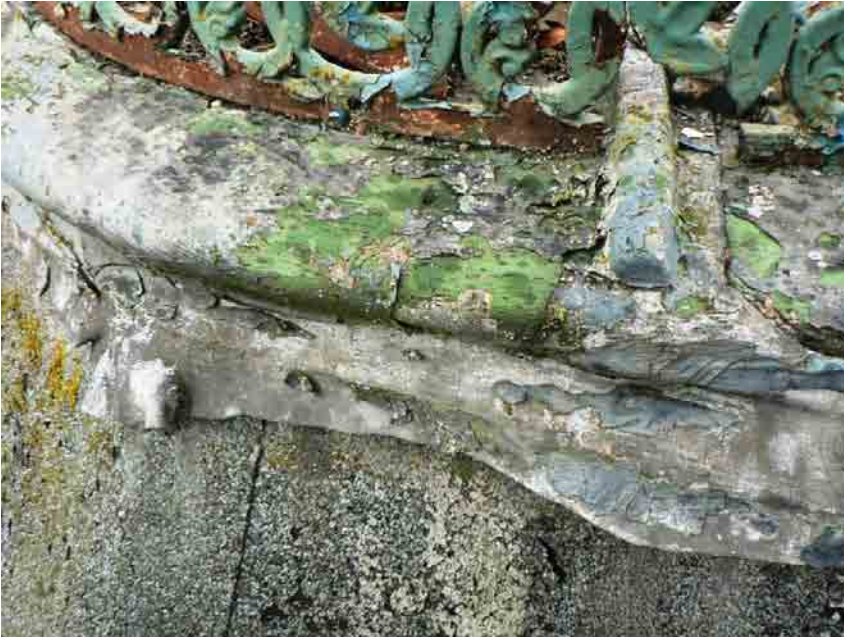
Remaining lead around seat to corona is original and has not been replaced. Evidence of Green paint coverings to seat but not main roof. Remnants of lead roll seen to the left.

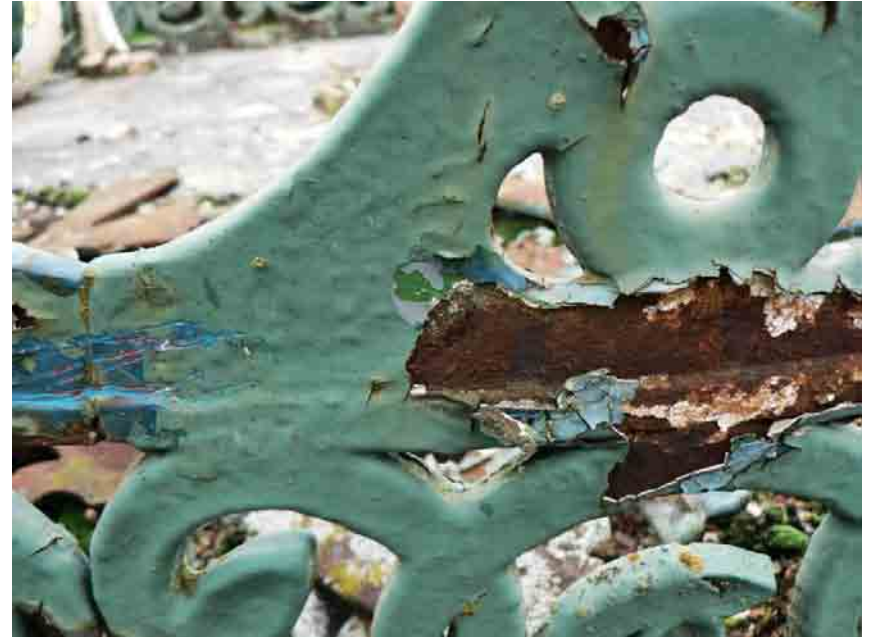
Corona evidence of light Green coating, then earlier light blue then earliest coat bright Green (seen in the centre of the image)

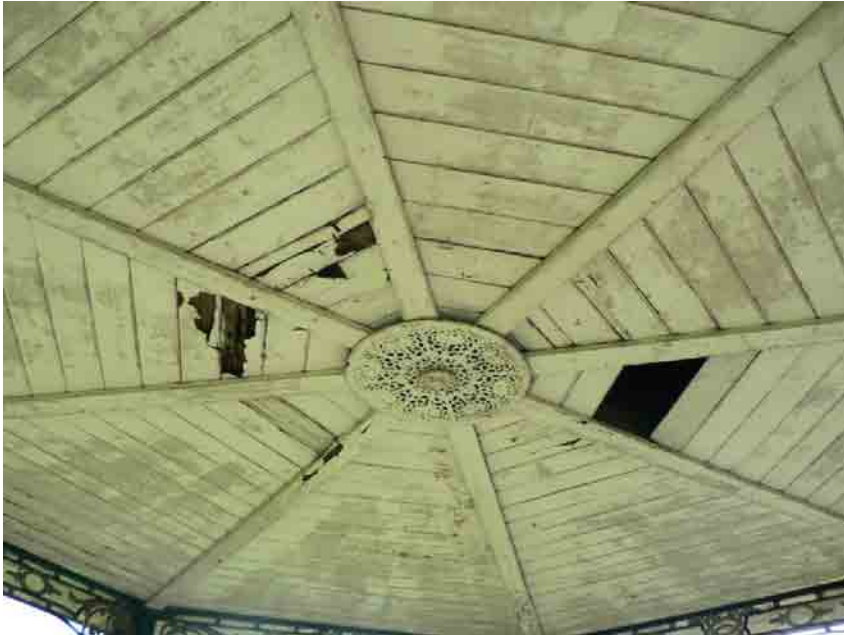
Soffit tongue and groove boards overall in good condition. Some replacement required. Many boards appear original

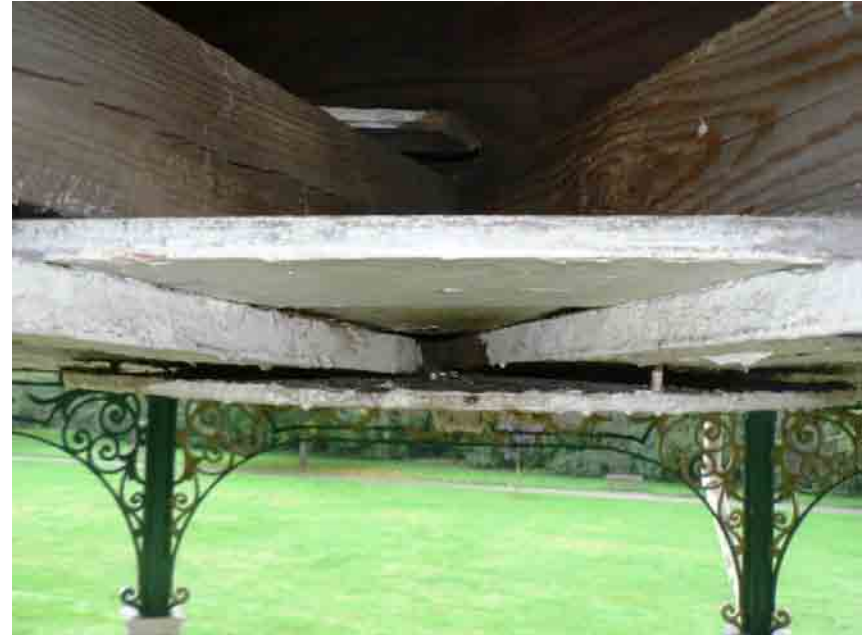
Major timbers above in good condition where exposed during investigation.

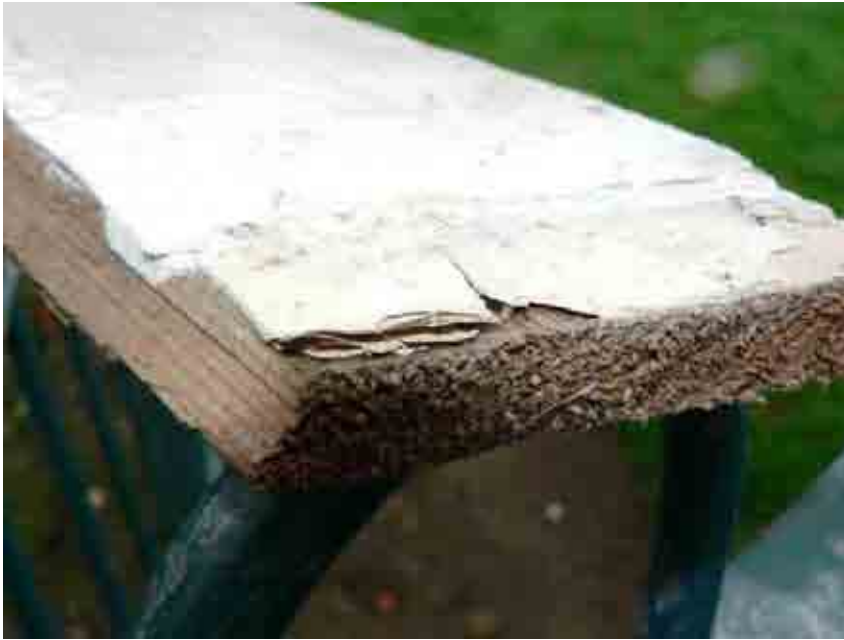
Soffit tongue and groove boards to soffit showing extensive paint layers over many years of application

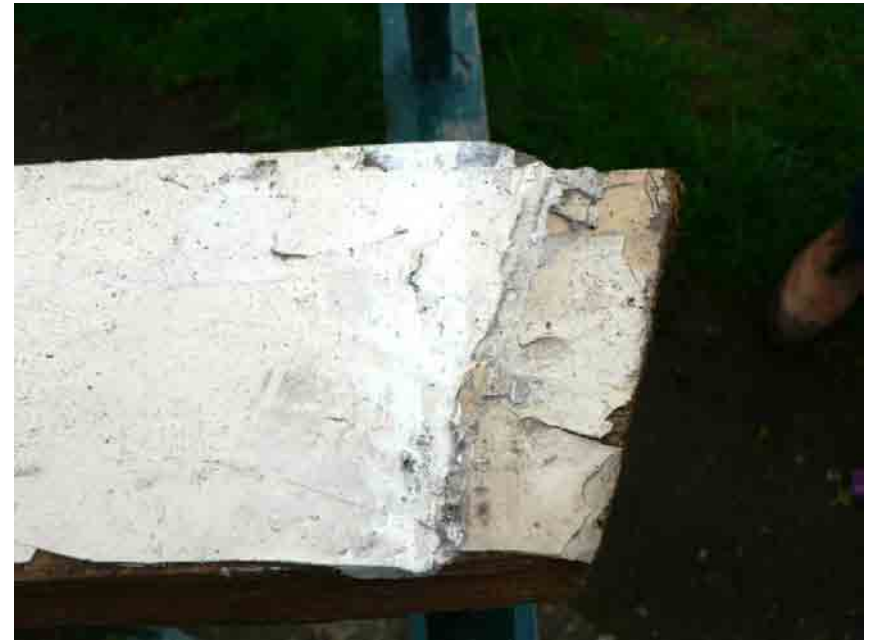
All paint layers visible under inspection exhibit light cream – dark cream colour. Lead paint expected but recovering possible with wet rubbing down

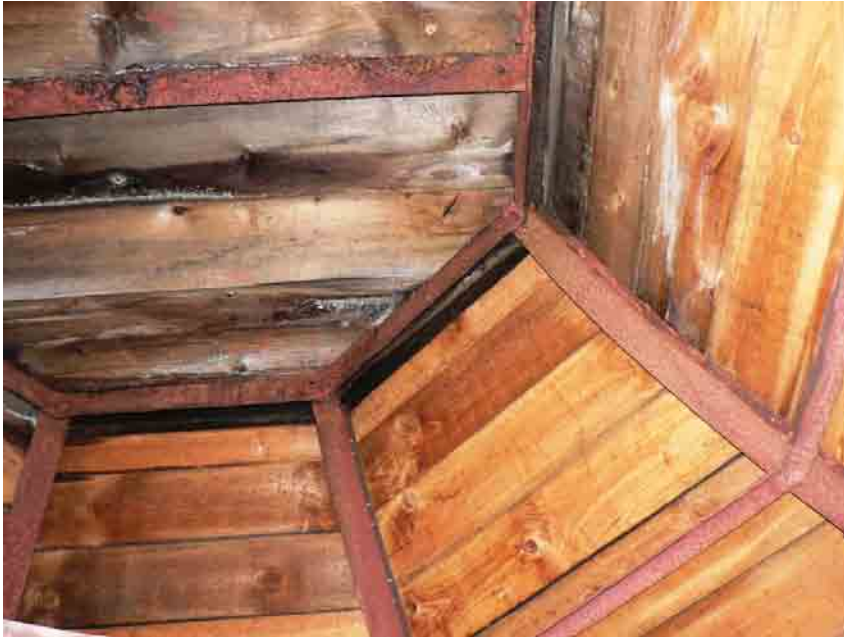
Roof boarding beneath felt has been replaced in recent years (within 20-30yrs), Self tapping non ferrous screws used to fix boarding to iron frame

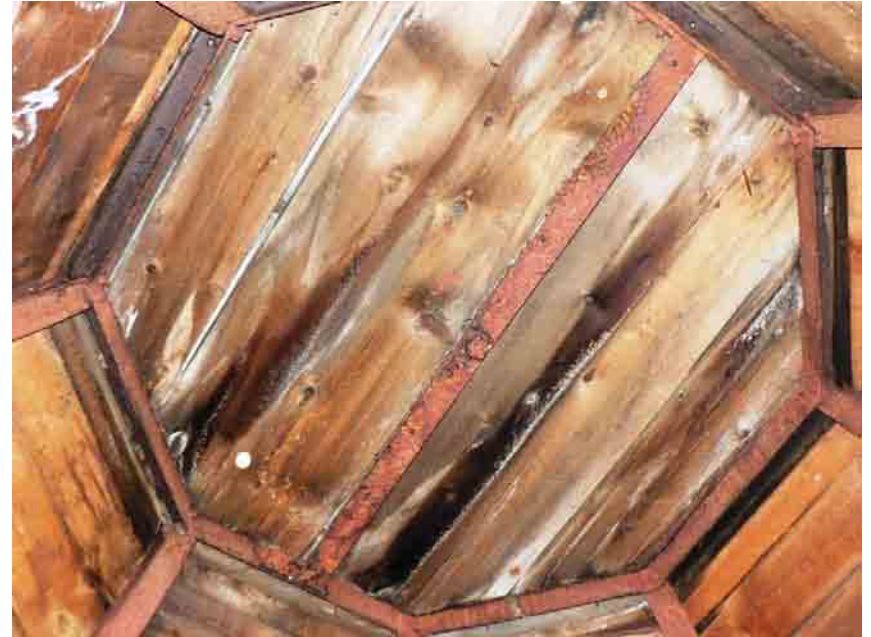
Area below Corona shows minor moisture ingress and retention but should stabilise following exposure and drying out. Majority of boarding can be used again. Some replacement will be required

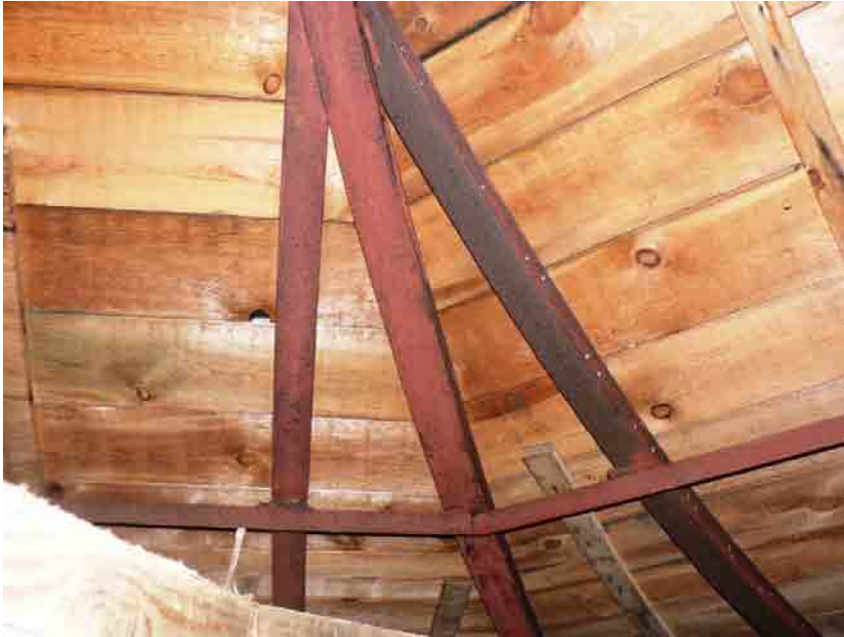
Iron frame work requires light abrasive clean and painting for protection in the long term.

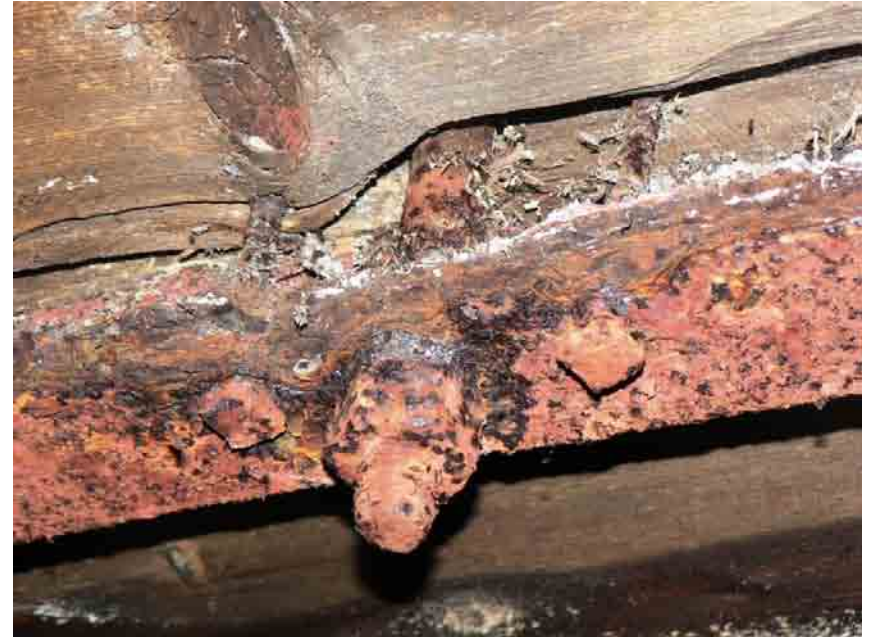
Iron support frame to Corona terminal showing evidence of corrosion to connecting rod and cross piece. Possible replacement to rod required.

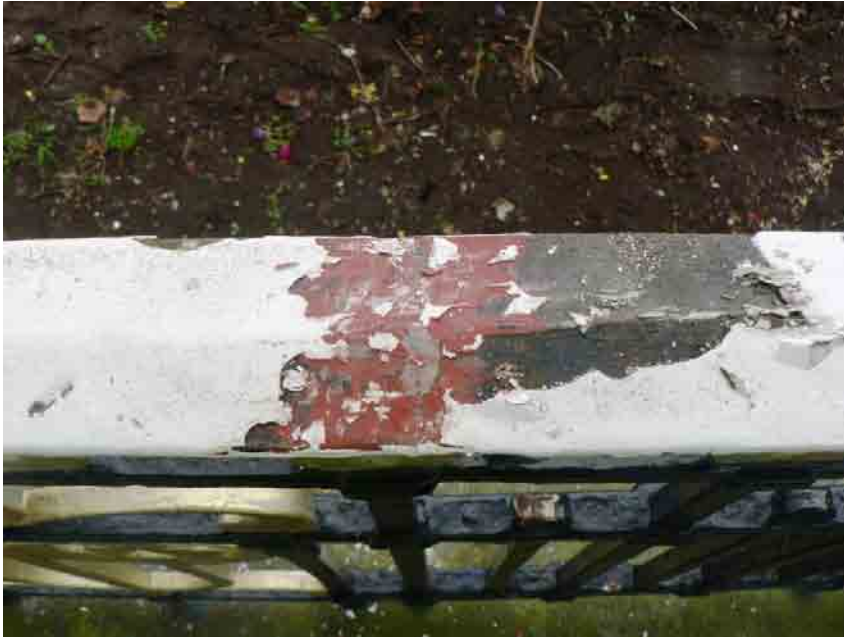
Hand rails have been cut and welded previously to all sides. Evidence of settlement historically. Some areas of previous poor repair will require cutting and re-welding

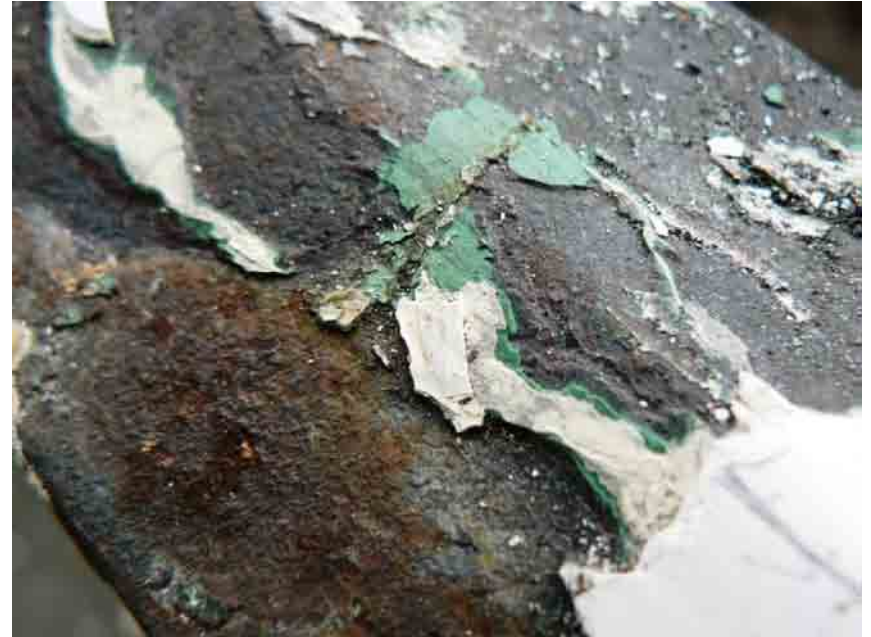
Build up of paint layers resulting in a loss of detail overall. Lowest paint layers are in evidence in a dark Green.

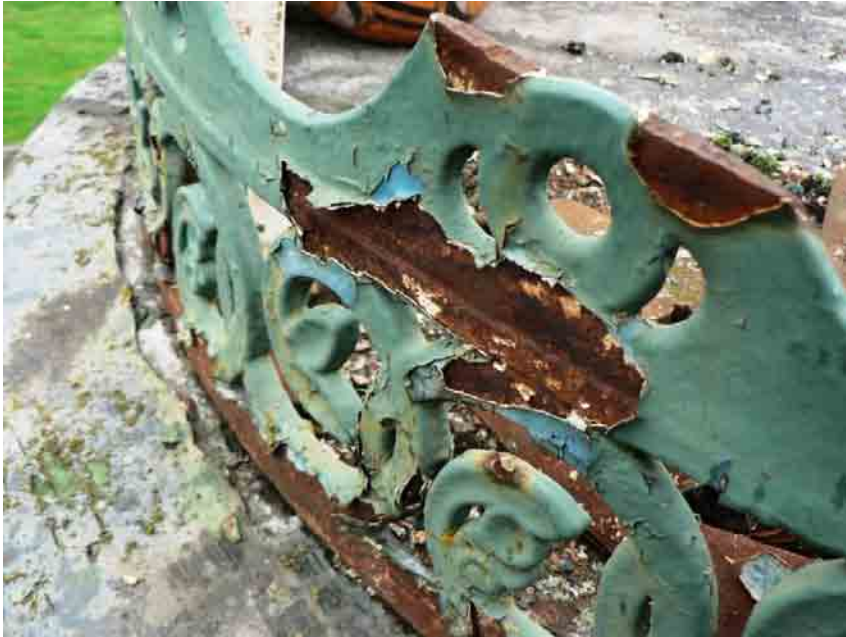
Extent of detailing lost through paint layers. No major corrosion to base.

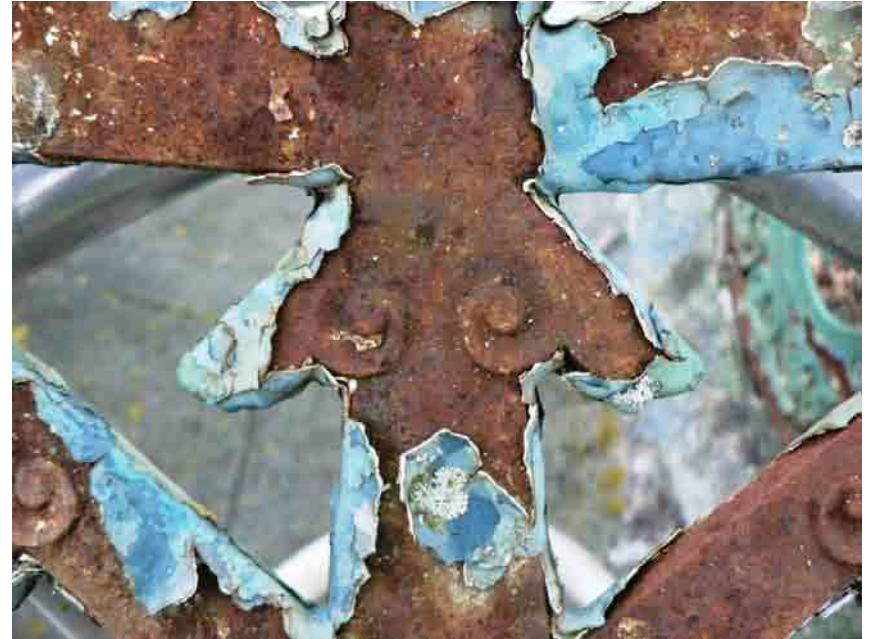
Floral volute detail of fronds of Corona previously lost under paint layering. Several pieces will require replacement and welding.

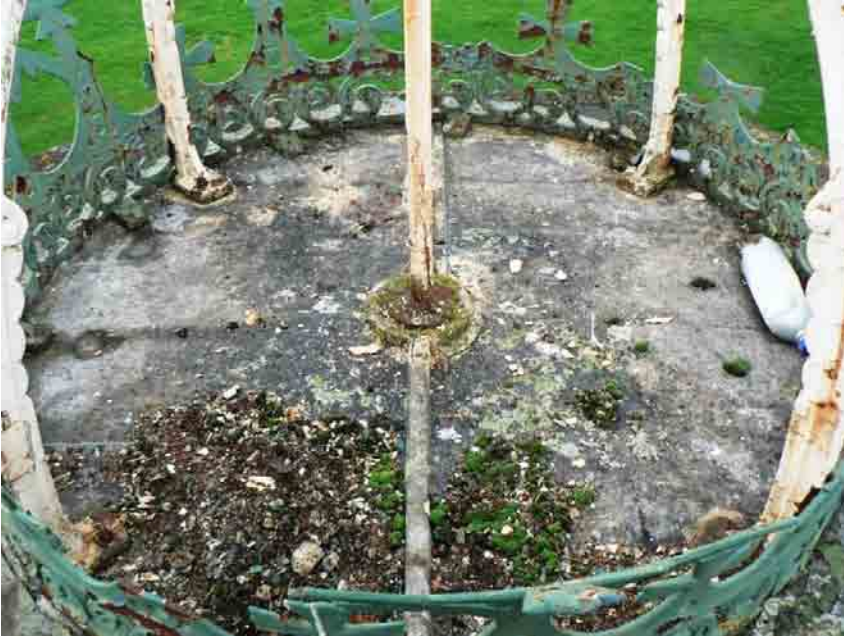
Lead protection poor. Perforated covering will allow direct penetration from rainwater onto iron work and timbers

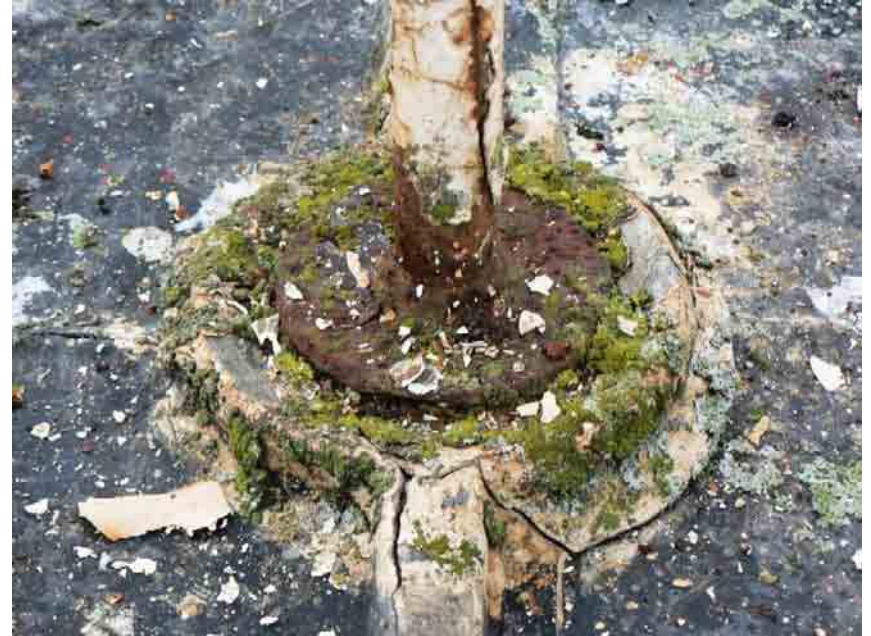
Water ingress point at fixing point of terminal. Corrosion developing at and beneath the terminal housing. New detail required.

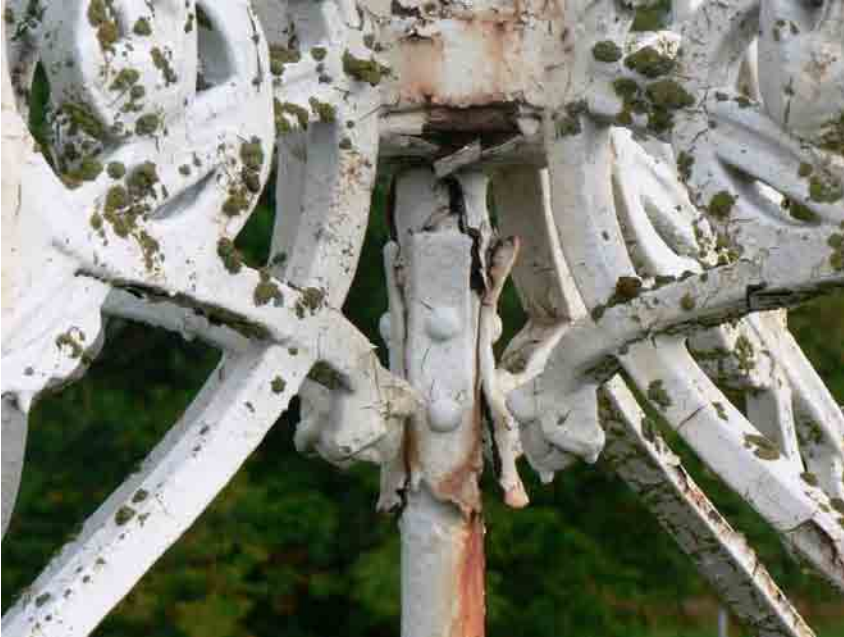
Terminal and Corona frame heavy corrosion. Area will need major work to support frame. New iron work back stays required. Corrosion at bracket and pin positions

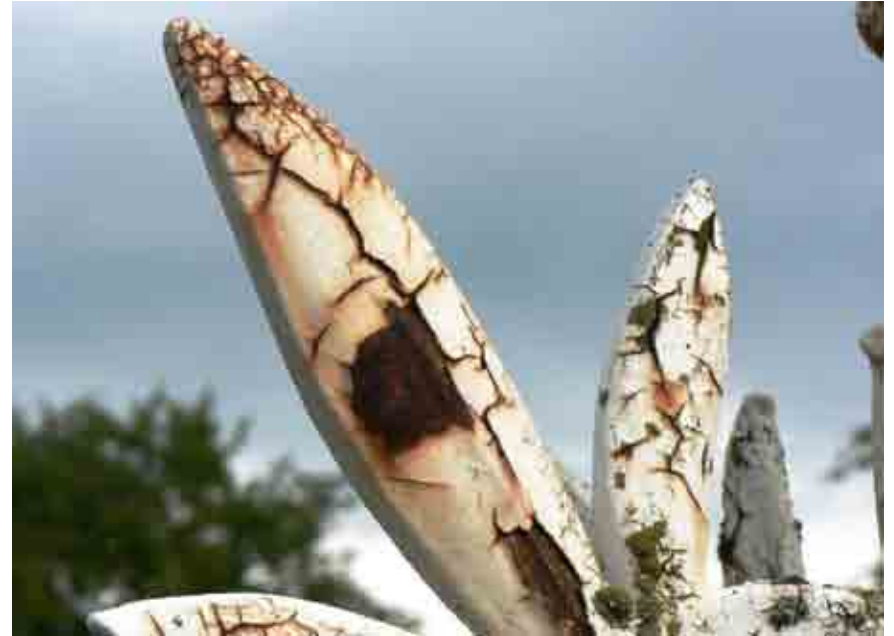
Leaf petal rib detail exposed exemplifying extent of original detail. Currently obscured by paint covering. Highly detailed ornate work.

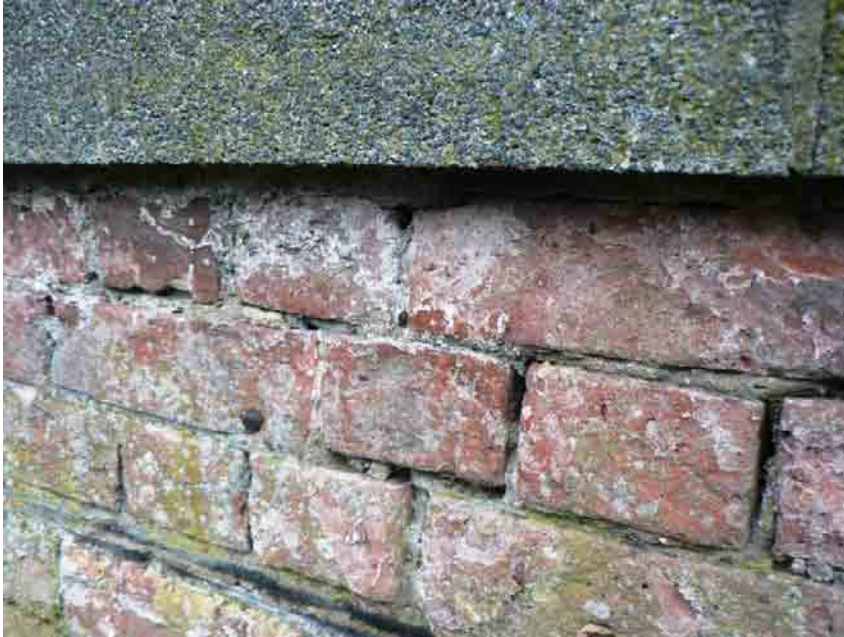
Medium soft red bricks obscured by remnants of later cement render coatings and pointing lost. Brick to be given water and aggregate abrasive clean to remove render (Vortech/Joss)

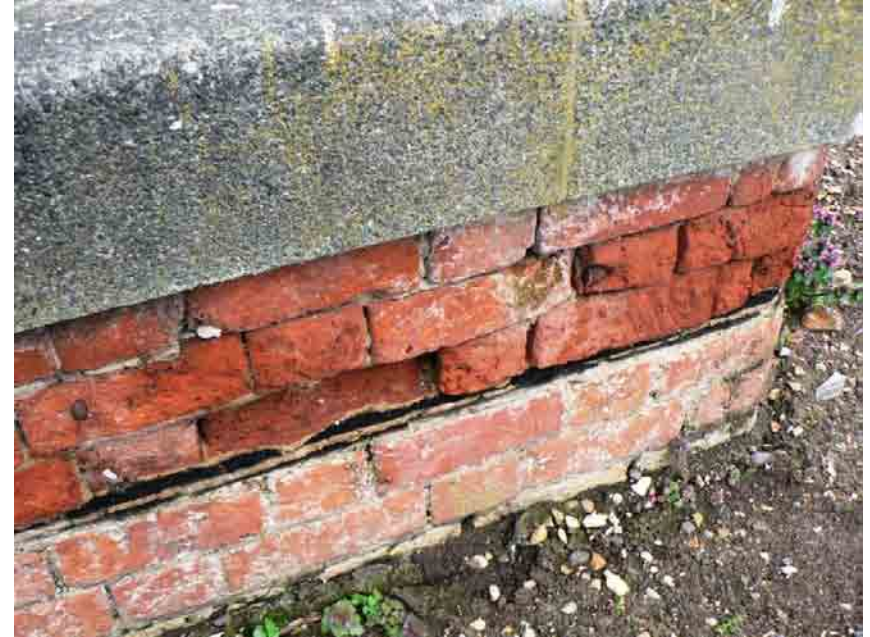
Brick indents will be required in medium soft imperial reds set in feebly hydraulic lime mortar. Note slate DPC.

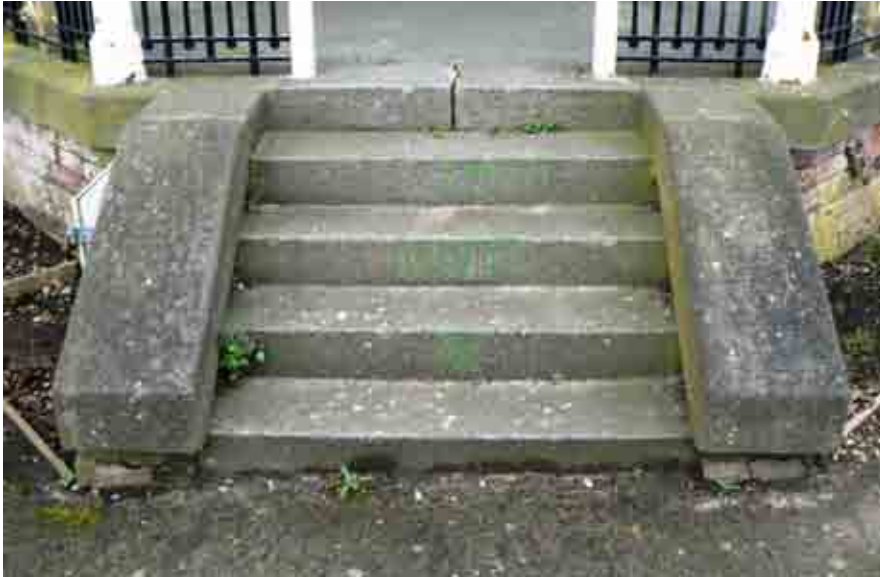
Granolithic concrete steps and landing will require deep steam cleaning and repair. Heavy duty anti slip paint can be employed as an option following mortar repairs to cracks.

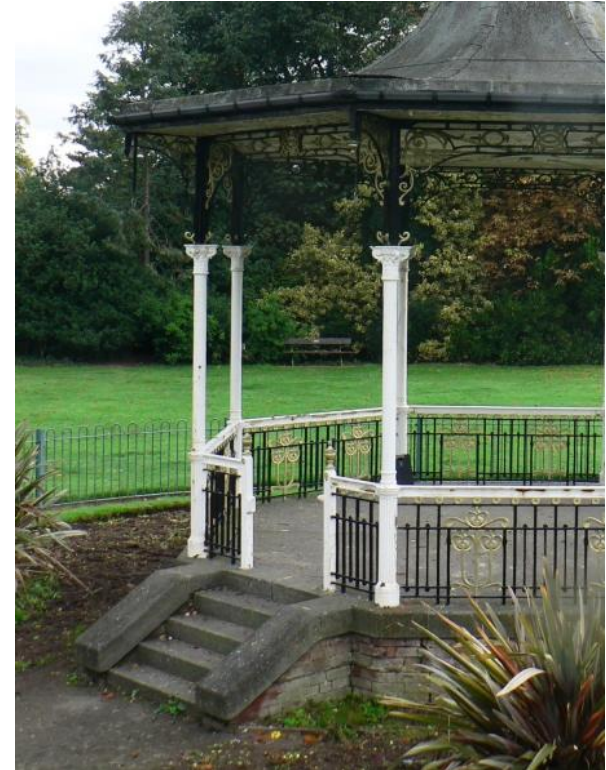
Missing gate should be included within overall budget for restoration. Detail of gate will effect overall final cost.

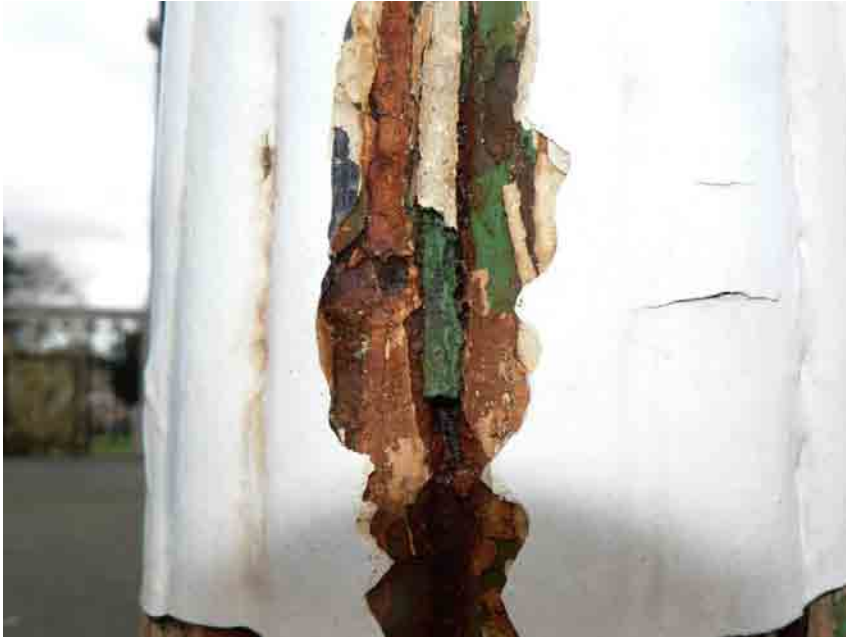
Evidence of ribbed detailing obscured. Delicacy of detail overall to bandstand aesthetically poor and illegible. Full return to detail is recommended.

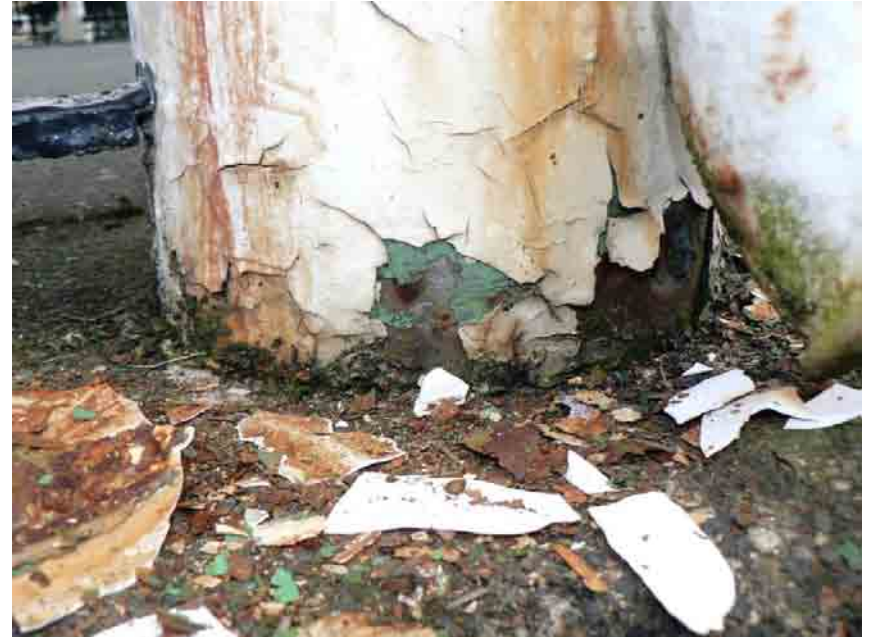
Column base and column both exhibiting green paint at the base layers
