# Beckenham Recreational Ground Bandstand (The Bowie Bandstand)

An iron pavilion for public performances

# MSc Building Conservation Unit BC4: Conservation of Metals Part 1 (Conservation of Metalwork)

# A Report of 19<sup>th</sup> century iron structure

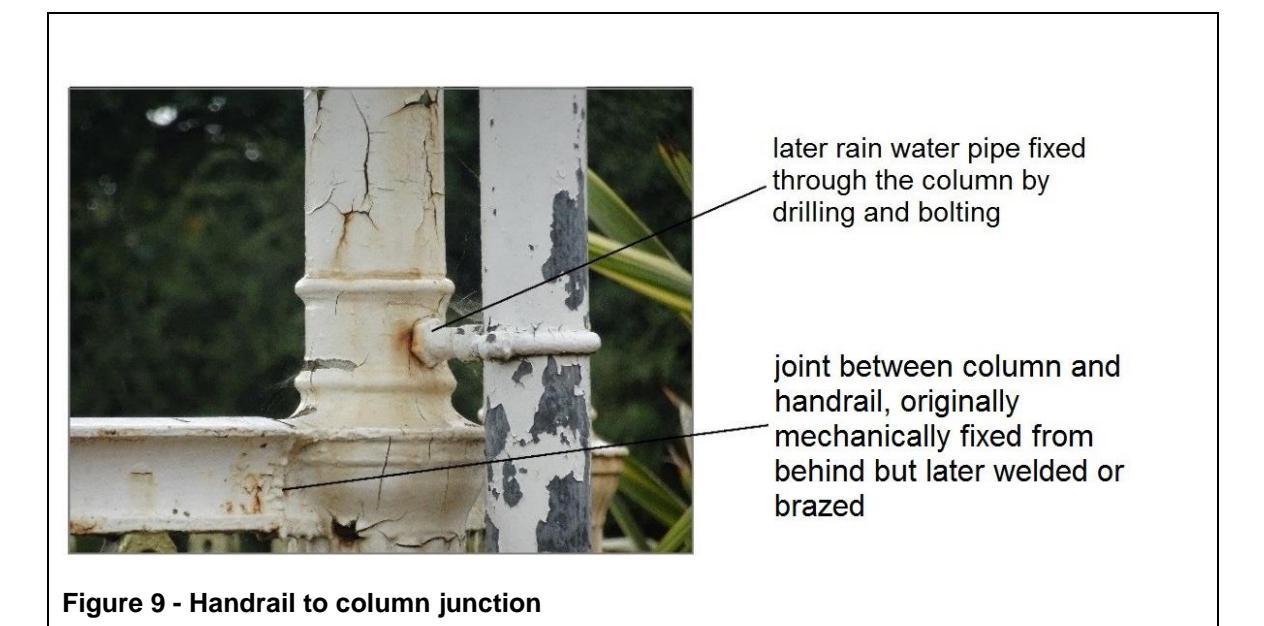
They were cast to include shorts stubs for connecting the handrails, Figure 9. The handrails were originally bolted to these but they have since also been brazed or welded. The quality of this later work appears poor.

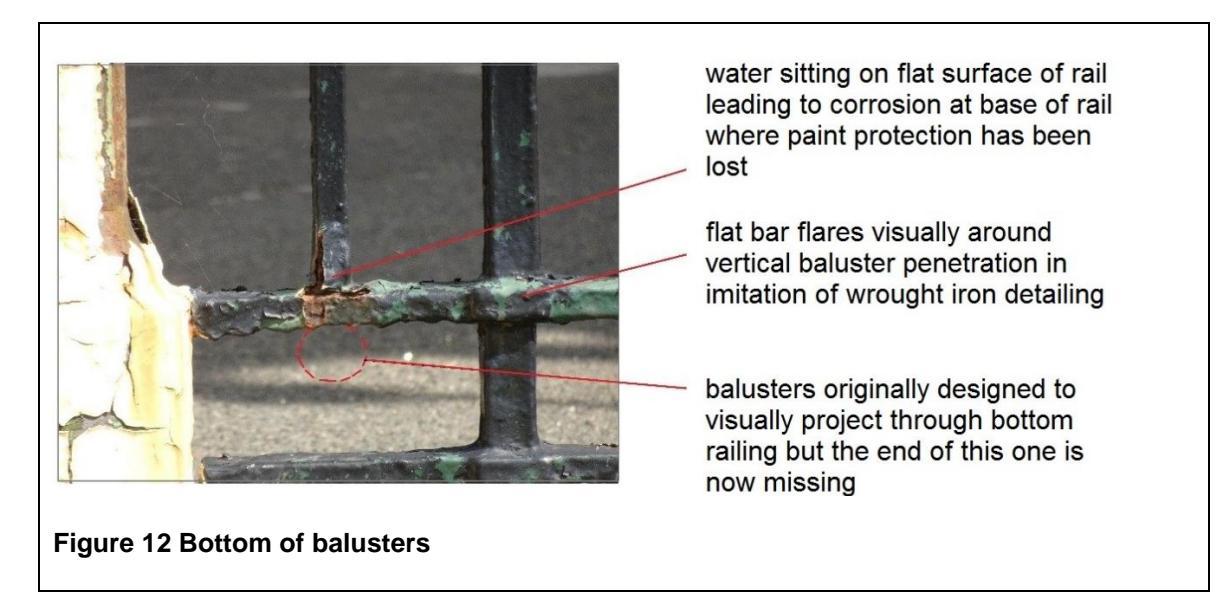
The railings and handrails have, despite neglect, survived well with only minor details missing, Figure 12.

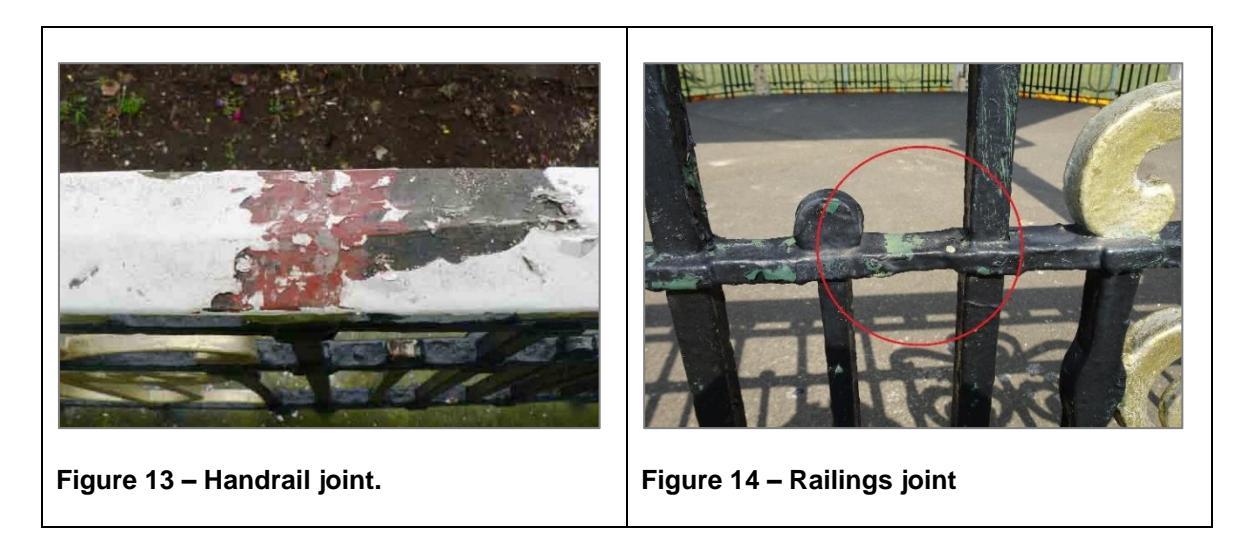
The railings are detailed with balusters projecting through the horizontal rails and their ends flattened in imitation of handmade wrought iron but are likely cast iron. Their sections are slightly tapered to ease the original patterns removal. Each appears fabricated in two unequal length sections and joined about a third of the way along from one end, as shown in Figure 11. Although mostly hidden below layers of paint the joints are visible in Figure 13 and Figure 14.

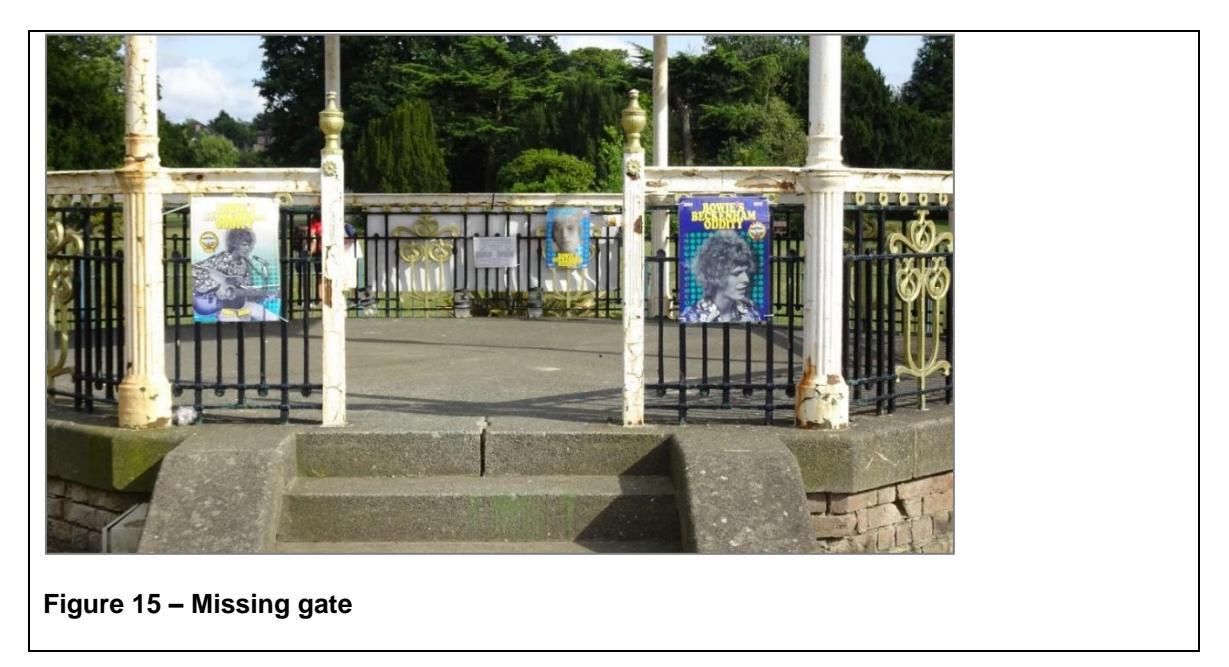
The eighth side contains an opening for a gate, which is now missing, Figure 15.

Most components can be exactly replicated from other surviving details, except the gate. The gates original form is unknown, and it might therefore be argued for it not to be replaced. However, it was an important functional part of the design and its reinstatement would be completely reversible, so a sympathetic replacement seems appropriate. The original gate would likely have included the motif, which is repeated elsewhere, as Figure 39.

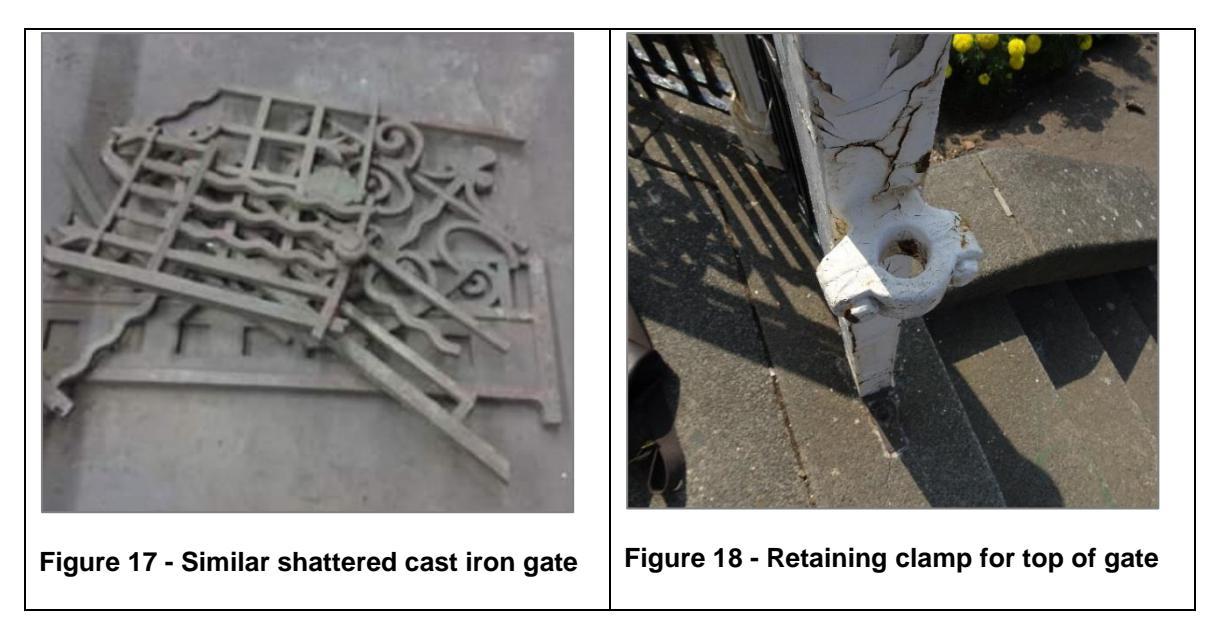
Grey cast iron lacks ductility making it vulnerable to shattering as Figure 17, which shows the remains of another similar gate also by McCallum & Hope.

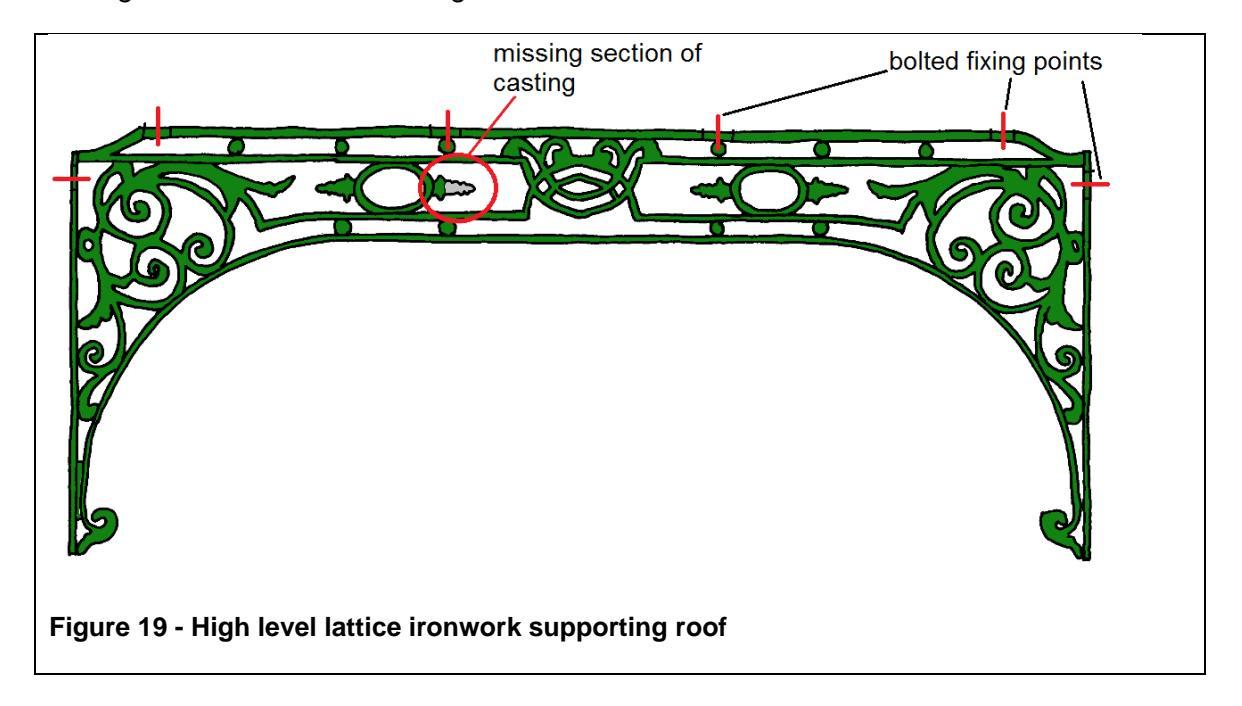
Eight high level decorative lattice beams span between the columns providing a base for the roof structure. These appears lighter than the railings and may include wrought iron, which is better suited structurally for members in tension as some lower parts of this would be. Further investigation is required. They appear complete, except for one missing the detail identified in Figure 19.

There are a few ornamental details lost from the original castings. These should be replicated by recasting and pinning using threaded stainless-steel bar coated in layers of paint and screwed into place whilst still wet. In areas where this is impractical then brazing may be used as an alternative, although it is not a preferred fixing method (Davey & Mitchell, 2009).

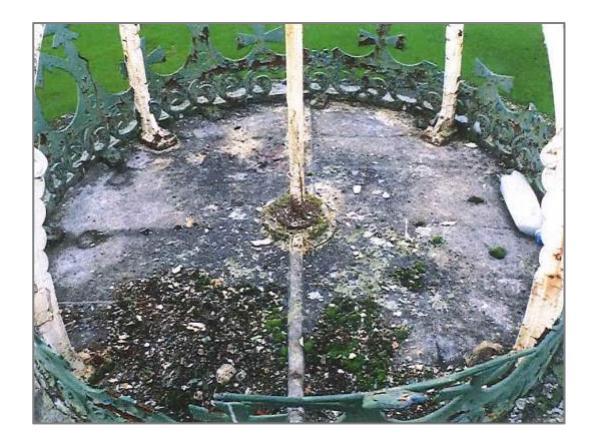
The roof was originally finished in lead as seen on the cover page. This still survives under the cupola and finial, Figure 21 and Figure 22, although elsewhere has been replaced by felt.

Figure 21 - life expired original roof lead work below cupula

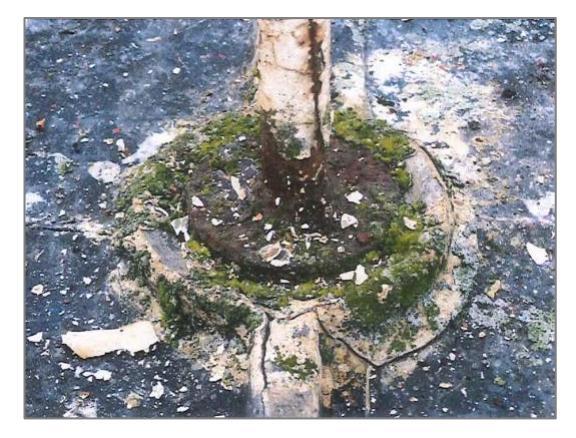
Figure 22 - Finial penetration of roof - now corroding

This metal structure appears sound, although its original red lead paint is now failing, particularly around the finial where water is penetrating the leadwork. It was welded or brazed rather than bolted together. The complete structure appears as Figure 25.

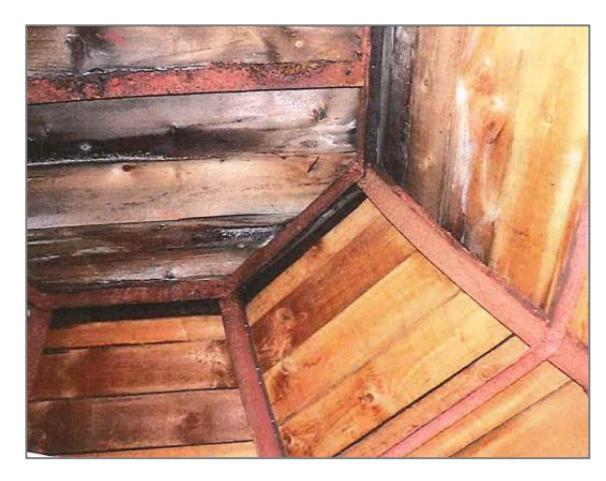
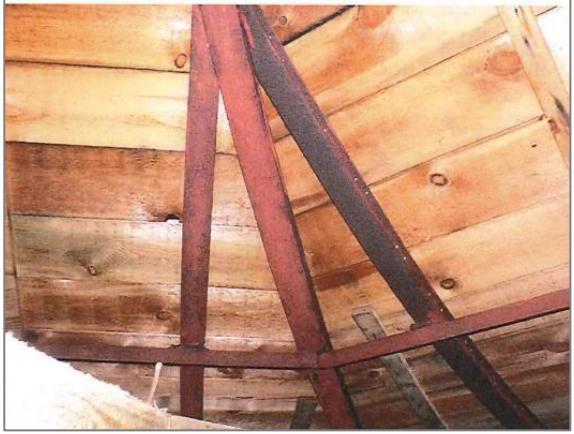
Figure 23 – Concealed roof structure below Figure 24 –Roof structure at mid-level cupula

The roof is carried on a metal substructure, probably wrought iron. It is mostly concealed above a timber ceiling but glimpses are visible where the ceiling is damaged, Figure 23 and Figure 24.

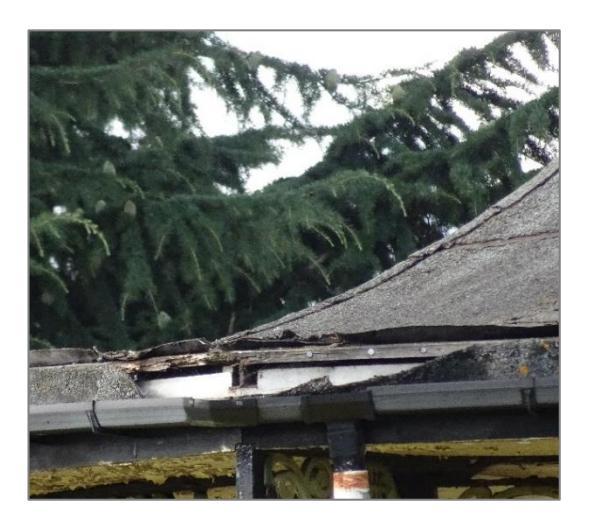
The original eaves detail, Figure 26, has been trimmed back and replaced with plastic guttering. The ragged cut ends of the structure are visible where the roofing felt has failed, Figure 27.

Figure 27 - Current eaves detail

The later rainwater goods should be removed, and the original detail sympathetically recreated. A full survey should identify whether the columns were originally used to drain the roof. If so then it may be appropriate to reinstate this function, but it should be noted that such drainage was prone to freezing and fracturing the cast iron.

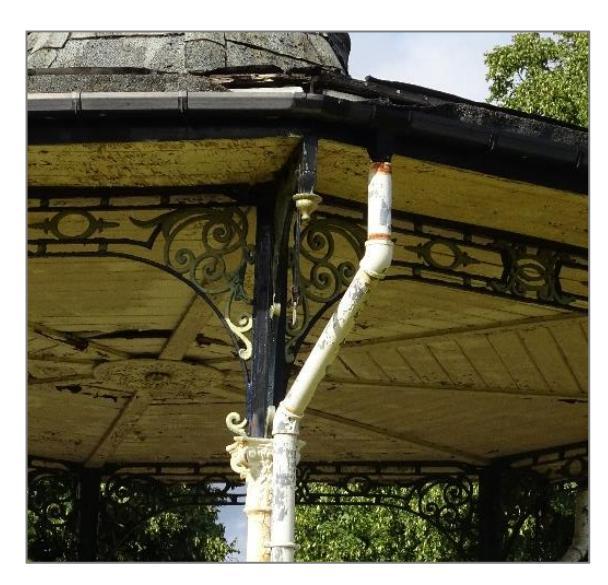
Further investigation would be necessary to establish if such a system was used in Beckenham. The current later downpipes are shown in Figure 29.

Figure 29 - Metal downpipe added

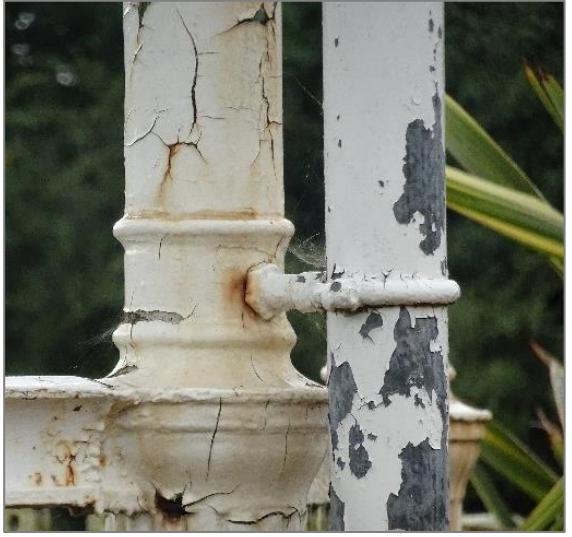
Figure 30 - Downpipe with fixings bolted through cast iron columns

These have been bolted through the columns, Figure 30, and are a source for water ingress, which through freeze thaw weathering may damage the columns. There is noticeable rust staining around the fixing.

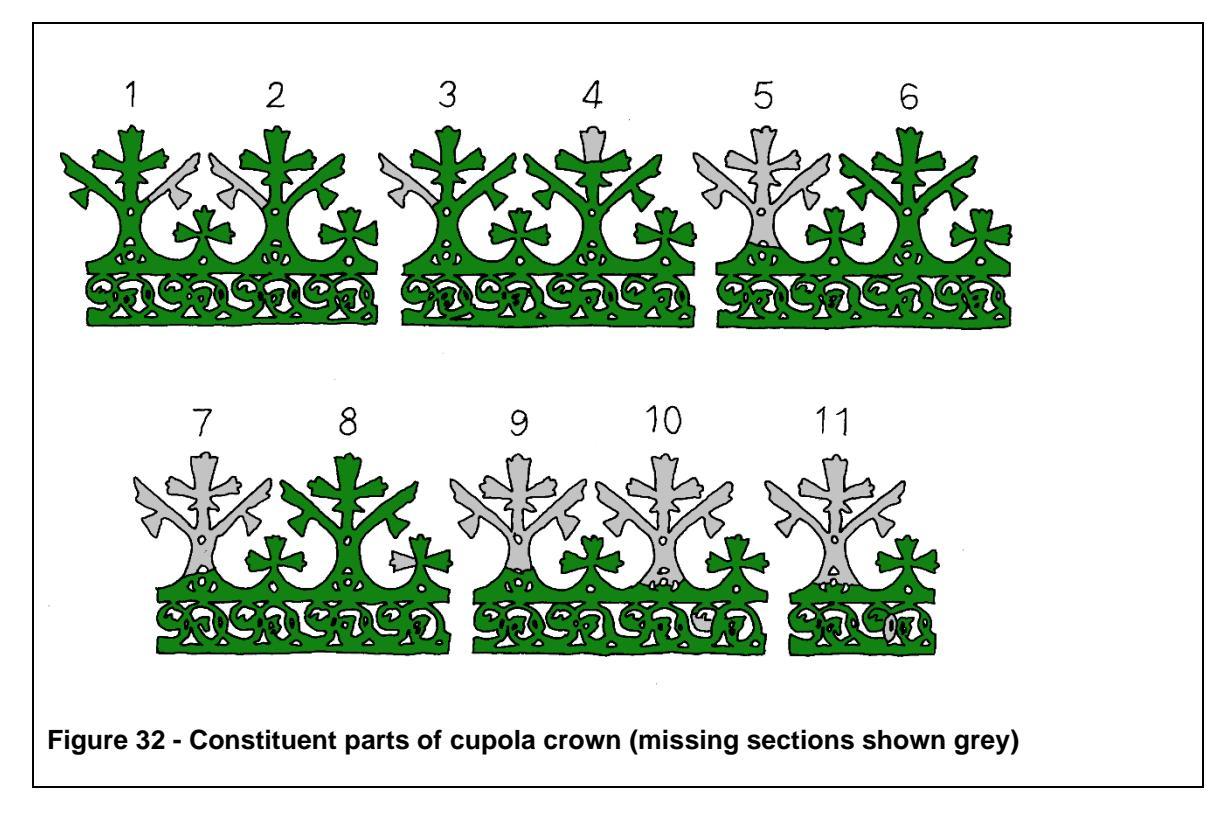
The base of the cupula appears formed from five identical iron parts and a single half size part, Figure 32

It is not clear if this feature is cast or wrought, but if cast then it would be surprising to find all parts not designed as identical. Casting is a repetitive process that is most economical when all the parts are the same. This and their relatively thin section suggest that they are likely wrought. Wrought iron is more malleable and could have been produced flat, perhaps from the foundries standard pattern book, then later curved to suit the required radius. Their metallurgy should be checked before attempting repair.

Elements of the cupola and finial appear quite thin and would be difficult to pin, however, they are likely wrought iron and if so may be welded or brazed.

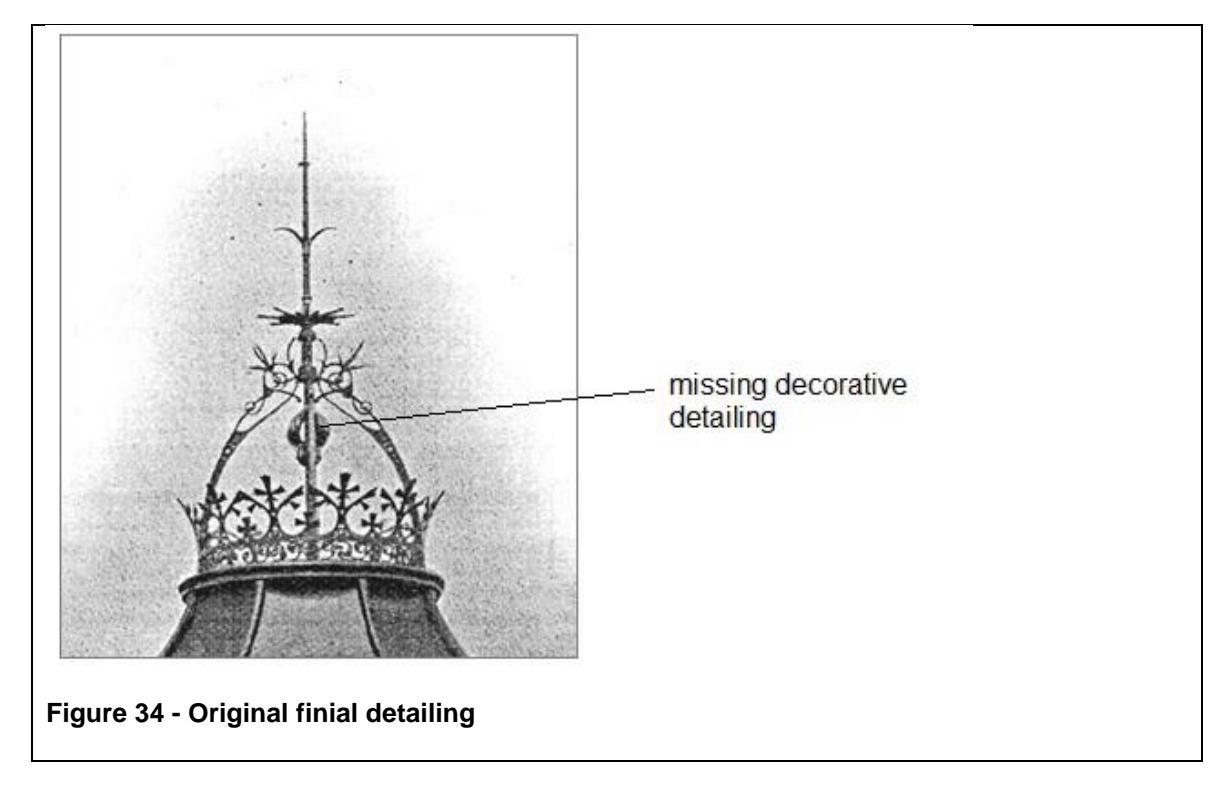
The finial is also missing some detail as shown in Figure 34.

These may have been either cast or wrought. Loss of original fabric should always be minimised but so little remains here that complete replacement is probably appropriate, particularly if they are cast as these would be a difficult repair. The finial higher up is generally complete but poorly protected due to paint loss and is now corroding, Figure 36.

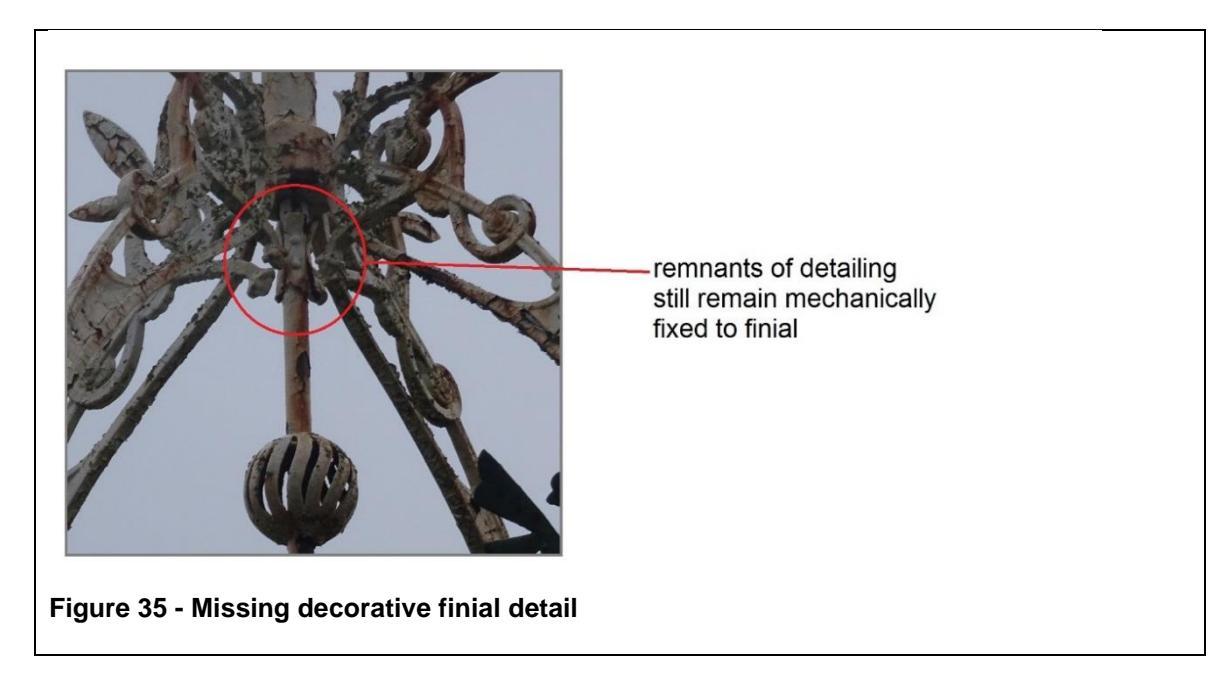
The top tails of these still exist fixed to the finial, Figure 35.

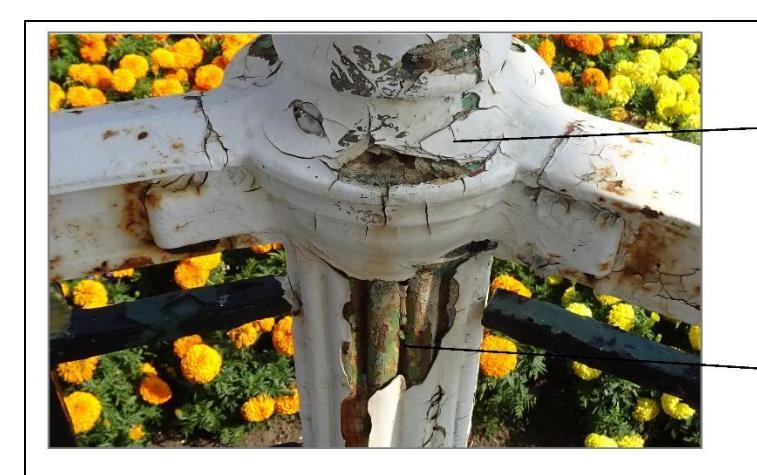
#### Figure 40 - Flaking paintwork

"The principle aim of conservation is to stabilise condition, stopping or slowing deterioration. For ferrous metalwork this generally means cleaning and recoating" (Godfraind, el al., 2012, p.175). The existing cracked paintwork will be trapping moisture, accelerating decay, as well as obscuring detail, Figure 40.

build up of paint layers obscuring fine decorative detailing

white paint and below that cream, flaking to reveal earlier and probably original dark green finish below

Before removing paint, samples should be taken for analysis and to guide later colour selection. There are several alternative methods for paint removal including mechanically, flame, chemical and blast cleaning. Blast cleaning is the fastest and most effective but usually restricted to structural ironwork as it can damage the surface (Godfraind, et al., 2012). Dry ice or ultra-high-water jetting may also be considered as they are less aggressive, although water jetting can force moisture into joints and porous castings (Godfraind, et al., 2012). Sample tests should be carried out in inconspicuous areas. Appropriate Health & Safety precautions should be put in place, particularly as the early layers are likely lead based. It may also be acceptable to allow areas of well adhered paint to remain in place rather than risk damaging the ironwork, although compatibility issues with the new coatings must be considered.

Removal of paint will expose joints and surface flaws, which should be filled with a filler compatible with the paint system. This will help prevent moisture ingress. All ironwork must be thoroughly dry before repainting. Iron was traditionally painted with linseed-based lead paints. However, there now are many modern lead-free alternatives that can be highly durable. Zinc based primers will also continue to provide protection by sacrificially corroding even if the paint finish becomes damaged. Hard epoxy paints are not generally flexible enough to allow adequate thermal expansion (Davey & Mitchell, 2009).
