# Beckenham Recreational Ground Bandstand (The Bowie Bandstand)

An iron pavilion for public performances

# MSc Building Conservation Unit BC4: Conservation of Metals Part 1 (Conservation of Metalwork)

# A Report of 19<sup>th</sup> century iron structure

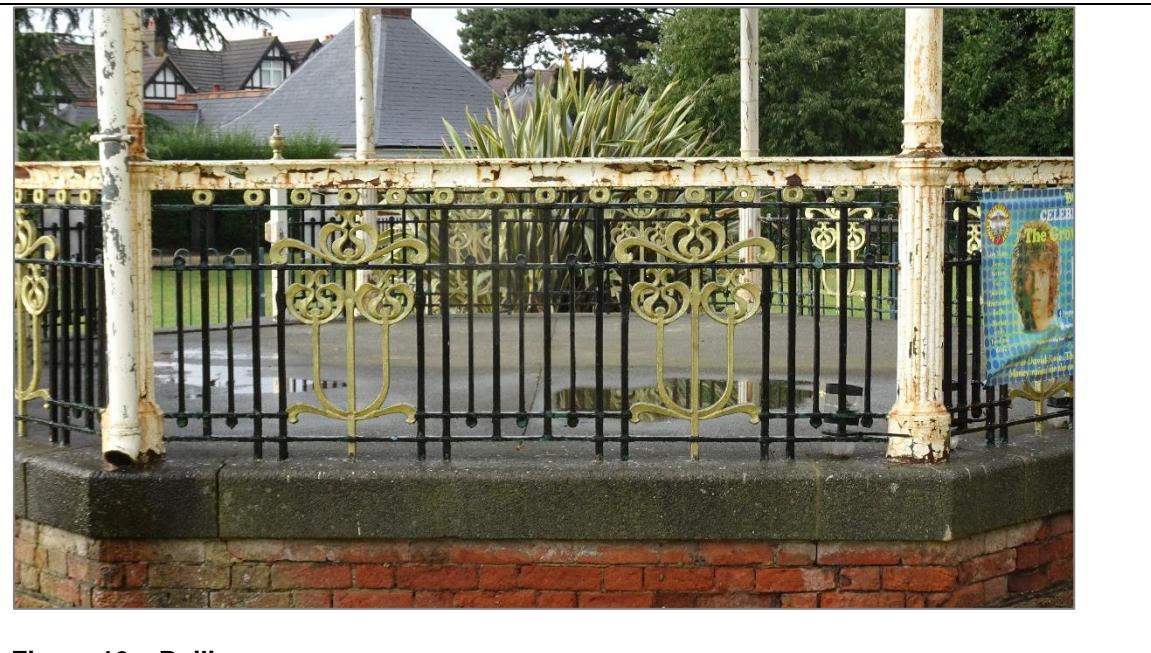
Figure 10 – Railings

The railings repeat on seven sides of the octagonal plan, spanning column to column, Figure 10.

The railings and handrails have, despite neglect, survived well with only minor details missing, Figure 12.

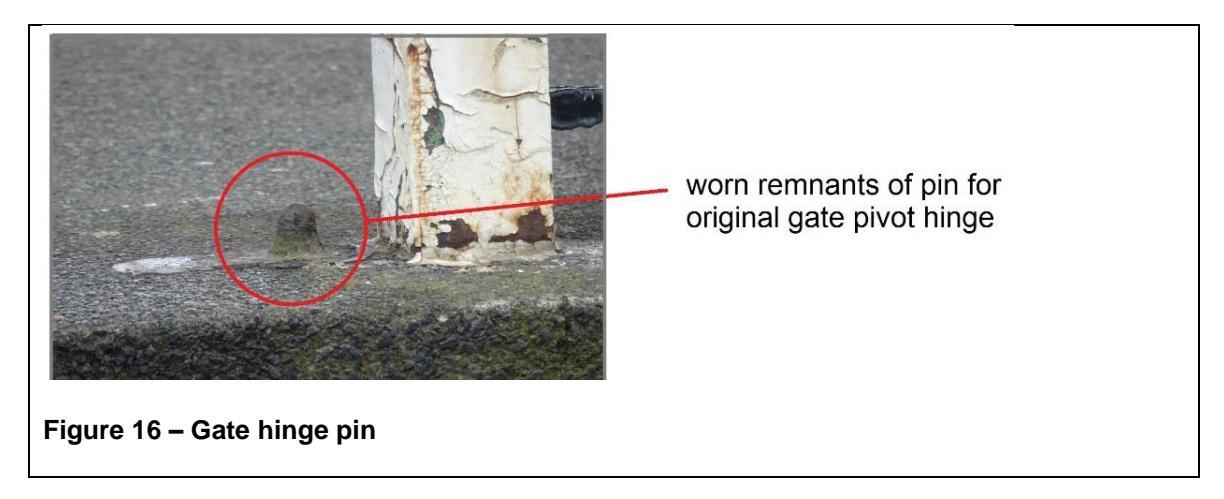
The gate would have opened into the bandstand and pivoted on a pin set into the concrete plinth, Figure 16.

Most components can be exactly replicated from other surviving details, except the gate. The gates original form is unknown, and it might therefore be argued for it not to be replaced. However, it was an important functional part of the design and its reinstatement would be completely reversible, so a sympathetic replacement seems appropriate. The original gate would likely have included the motif, which is repeated elsewhere, as Figure 39.

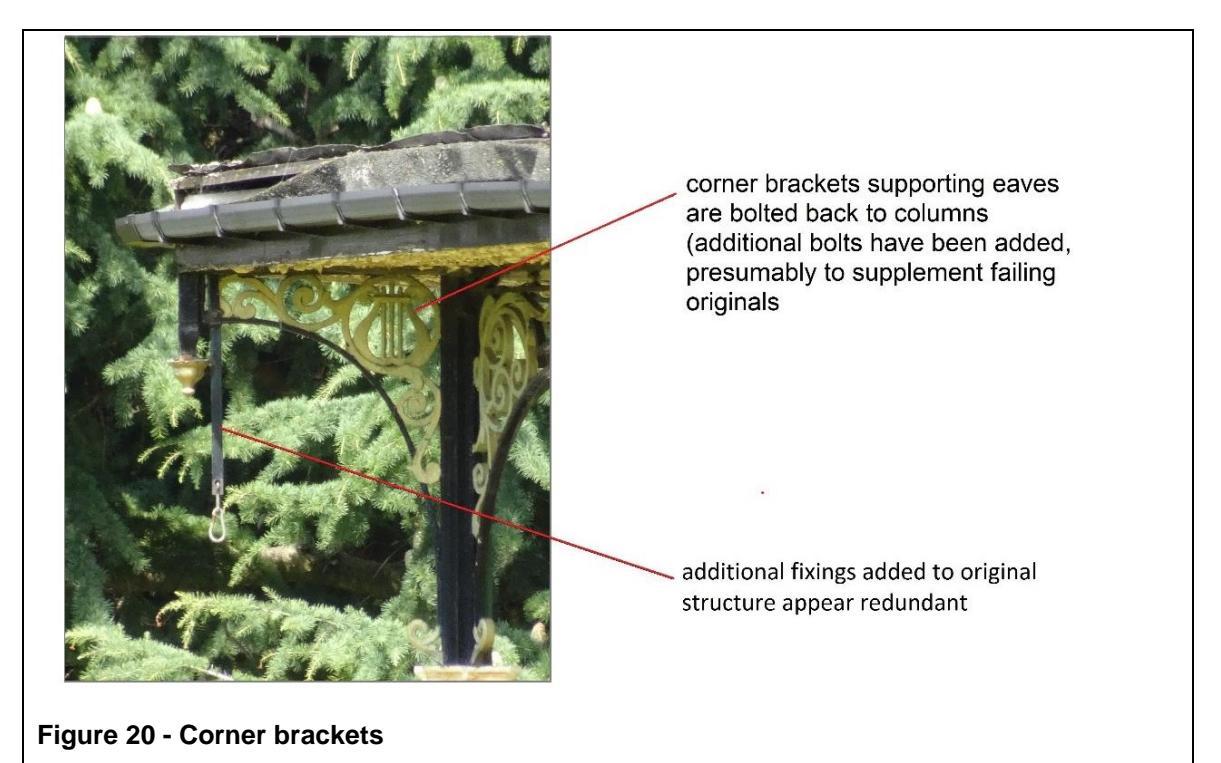
Cast iron brackets radiate out from each of the columns to support the roof, as Figure 20 and are complete.

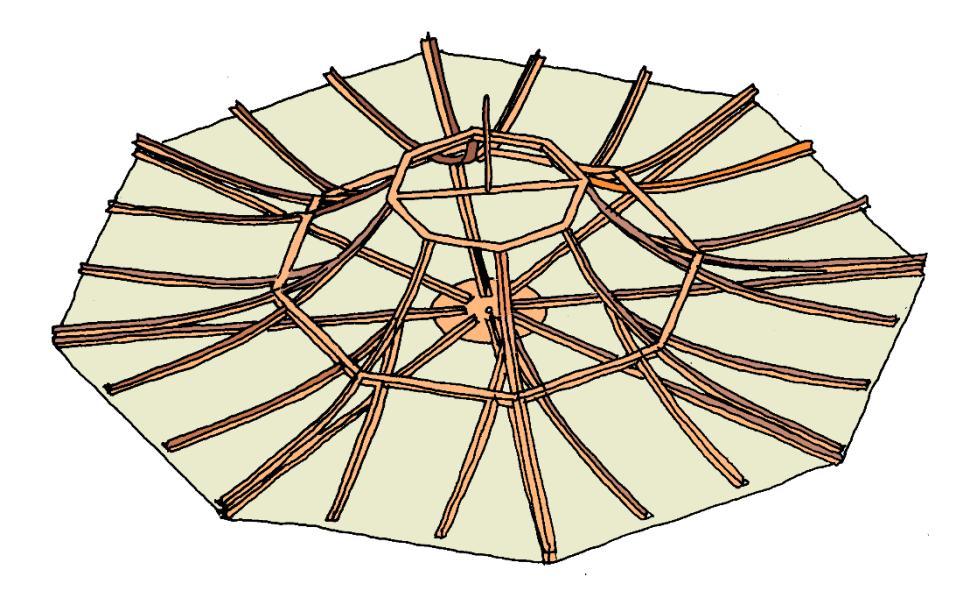
Figure 25 - Roof structural framing

This metal structure appears sound, although its original red lead paint is now failing, particularly around the finial where water is penetrating the leadwork. It was welded or brazed rather than bolted together. The complete structure appears as Figure 25.

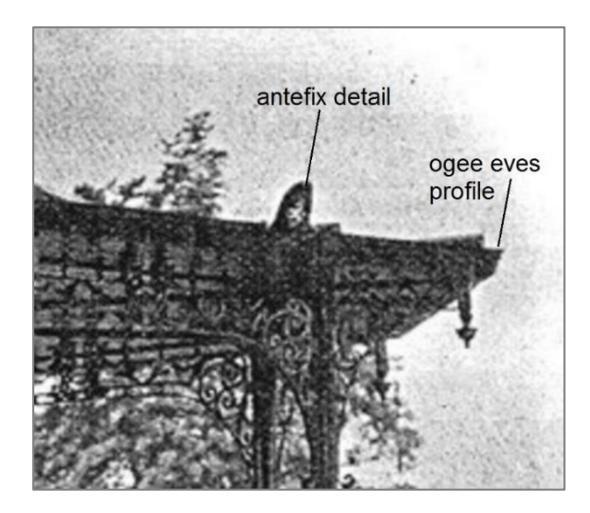
Figure 26 - Original eaves detail

The original eaves detail, Figure 26, has been trimmed back and replaced with plastic guttering. The ragged cut ends of the structure are visible where the roofing felt has failed, Figure 27.

The later rainwater goods should be removed, and the original detail sympathetically recreated. A full survey should identify whether the columns were originally used to drain the roof. If so then it may be appropriate to reinstate this function, but it should be noted that such drainage was prone to freezing and fracturing the cast iron.

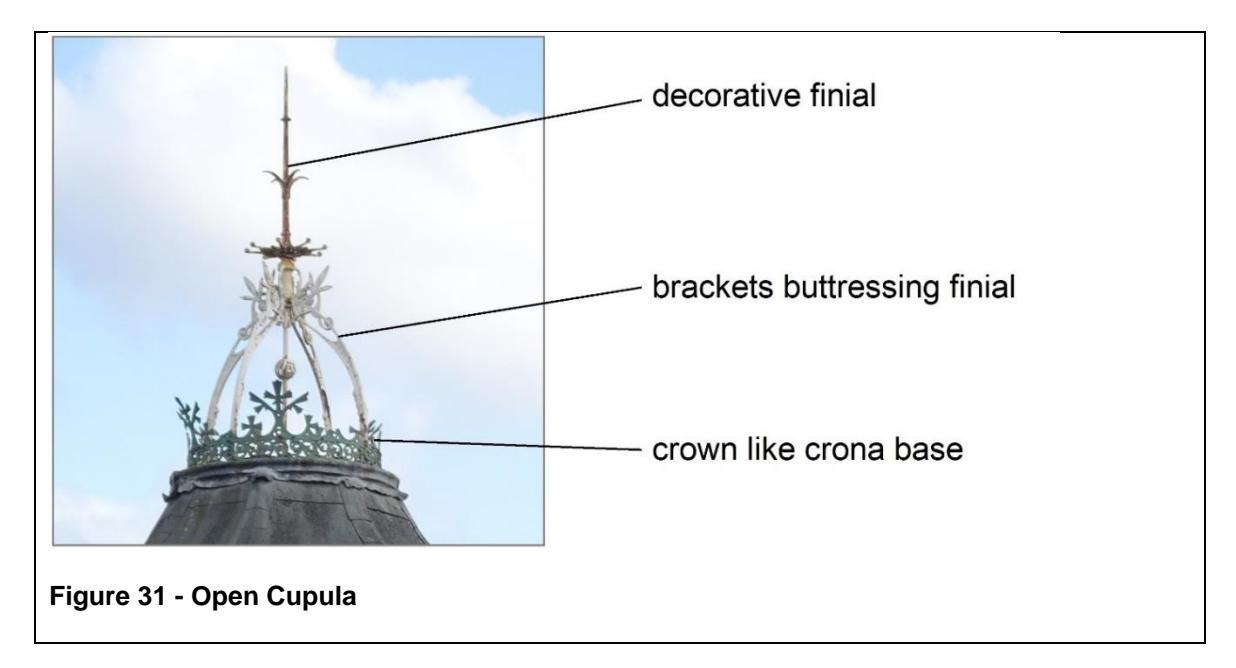
The bandstand is crowned by an open cupula with a decorative finial, Figure 31.

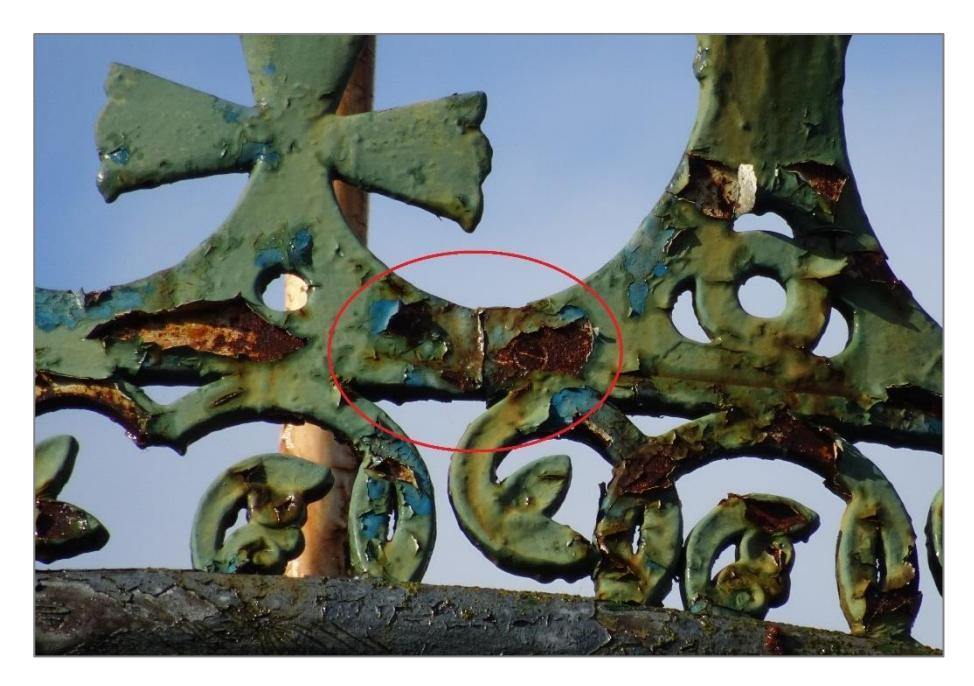
The sections are curved in two dimensions, relatively thin and bolted together with slot headed fixings, Figure 33.

Figure 33 - Sections bolted together

It is not clear if this feature is cast or wrought, but if cast then it would be surprising to find all parts not designed as identical. Casting is a repetitive process that is most economical when all the parts are the same. This and their relatively thin section suggest that they are likely wrought. Wrought iron is more malleable and could have been produced flat, perhaps from the foundries standard pattern book, then later curved to suit the required radius. Their metallurgy should be checked before attempting repair.
